HISTORIC RESOURCES INVENTORY
BUILDING AND STRUCTURES
 HIST-6 NEW 5/77

IDENTIFICATION	1. BUILDING NAME (Common) _____ (Historic)	
	2. TOWN CITY THOMPSON	VILLAGE QUADDICK
	3. STREET AND NUMBER (and/or location) 236 QUADDICK ROAD (424 QUADDICK RO.) 143/16-15

CONTINUATION SHEET
 Item number: _____ Date: 236 Quaddick Road

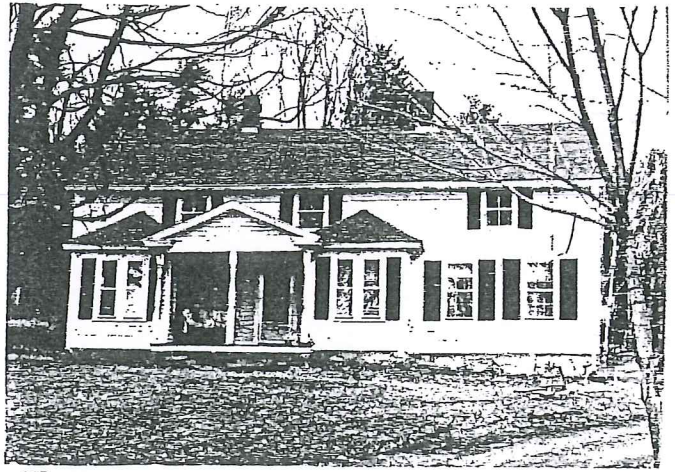
PHOTO	PHOTOGRAPHER Mark McDonough	DATE 1986
	VIEW N; NW	NEGATIVE ON FILE I28; I29
COMPILED BY	NAME Mark McDonough	DATE 1986
	ORGANIZATION Town of Thompson, Connecticut	
	ADDRESS

11. NUMBER OF STORIES: 1 1/2 APPROXIMATE DIMENSIONS: 42' x 20'	
	12. CONDITION (Structural) _____ (Exterior)	
	<input type="checkbox"/> Excellent <input checked="" type="checkbox"/> Good <input type="checkbox"/> Fair <input type="checkbox"/> Deteriorated <input type="checkbox"/> Excellent <input checked="" type="checkbox"/> Good <input type="checkbox"/> Fair <input type="checkbox"/> Deteriorated

13. INTEGRITY (Location) _____ WHEN? _____ (Alterations) _____ IF YES, EXPLAIN _____	
	<input checked="" type="checkbox"/> On original site <input type="checkbox"/> Moved <input checked="" type="checkbox"/> Yes <input type="checkbox"/> No Later porch, bay windows.

17 OTHER NOTABLE FEATURES OF BUILDING OR SITE *(interior and/or exterior)*
 Five-bay facade, entry in second. Entry flanked by hip-roofed rectangular bay windows with narrow paired 1-over-1 sash. Molded cornices on small jigsawn brackets.

Between bays, a very plain gabled entry portico on a single turned post; molded cornice shows partial return. Sash is mixed; generally 6-over-6 and 2-over-2. Three irregularly spaced frieze-band attic windows. Plain corner pilasters and frieze; molded cornice shows partial return.

Twin brick chimneys.
