HISTORIC RESOURCES INVENTORY
BUILDING AND STRUCTURES
 HIST-6 NEW 5/77

IDENTIFICATION	1. BUILDING NAME (Common) (Historic)		JOHN BUCHANAN HOUSE		
	2. TOWN CITY	VILLAGE	COUNTY		
	THOMPSON	QUADDICK	WINDHAM		
	3. STREET AND NUMBER (and/or location)		DATE OF CONSTRUCTION		
	1739 QUADDICK TOWN FARM ROAD (988 QUADDICK T.F.R.D.)		c. 1840

7. STYLE OF BUILDING		DATE OF CONSTRUCTION		
Greek Revival		c. 1840			
DESCRIPTION	8. MATERIAL(S) (Indicate use or location when appropriate)				
	<input checked="" type="checkbox"/> Clapboard	<input type="checkbox"/> Asbestos Siding	<input checked="" type="checkbox"/> Chimney Brick	<input type="checkbox"/> Other (Specify)	
	<input type="checkbox"/> Wood Shingle	<input type="checkbox"/> Asphalt Siding	<input checked="" type="checkbox"/> Fieldstone	Foundation	
	<input type="checkbox"/> Board & Batten	<input type="checkbox"/> Stucco	<input type="checkbox"/> Cobblestone		
	<input type="checkbox"/> Aluminum Siding	<input type="checkbox"/> Concrete Type:	<input type="checkbox"/> Cut stone Type:

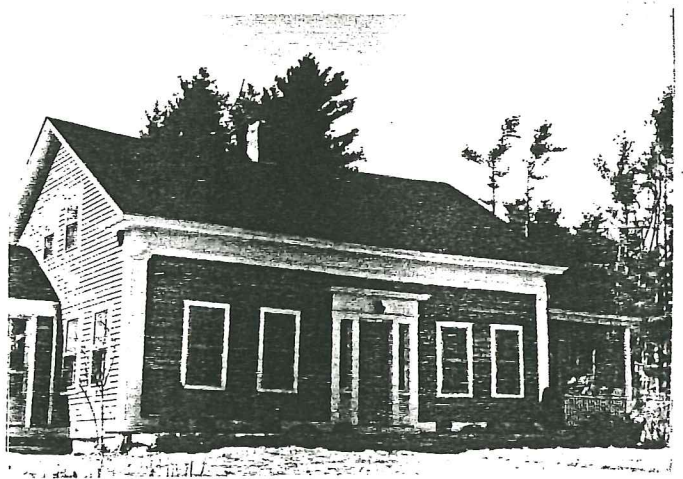
PHOTO	PHOTOGRAPHER Mark McDonough		DATE 1986
	VIEW NW	NEGATIVE ON FILE L26	
COMPILED BY	NAME Mark McDonough		DATE 1986
	ORGANIZATION Town of Thompson, Connecticut		
	ADDRESS

Five-bay facade, central entry. Sash generally 2-over-2. Entry has rectangular sidelights over panels, flanked by plain pilasters. Above, molded architrave, plain cornice, flat molded cap. Door has one large light over deeply molded panels.

Plain corner pilasters with molded capitals, molded architrave, wide plain frieze; molded cornice shows partial return. Right elevation has side entry in c. 1915 open porch on Tuscan columns with a square rail and balusters. To left, lower one-and-one-half-story ell with additional entry.
