**HISTORIC RESOURCES INVENTORY**  
**BUILDING AND STRUCTURES**  
 HIST-6 NEW 5/77

IDENTIFICATION	1. BUILDING NAME (Common) _____ (Historic) _____	
	2. TOWN CITY THOMPSON	VILLAGE QUADDICK
	3. STREET AND NUMBER (and/or location) 74 QUADDICK ROAD (516 QUADDICK RO.) 143/16-6

7. STYLE OF BUILDING Greek Revival/Victorian Vernacular	
	DATE OF CONSTRUCTION c. 1865	
	8. MATERIAL(S) (Indicate use or location when appropriate)	
	<input checked="" type="checkbox"/> Clapboard <input type="checkbox"/> Asbestos Siding <input checked="" type="checkbox"/> Chimney <input type="checkbox"/> Brick <input type="checkbox"/> Other (Specify) _____ <input checked="" type="checkbox"/> Wood Shingle <input type="checkbox"/> Asphalt Siding <input checked="" type="checkbox"/> Fieldstone Foundation <input type="checkbox"/> Board & Batten <input type="checkbox"/> Stucco <input type="checkbox"/> Cobblestone <input type="checkbox"/> Aluminum Siding <input type="checkbox"/> Concrete Type: _____ <input type="checkbox"/> Cut stone Type: _____	
DESCRIPTION	9. STRUCTURAL SYSTEM	
	<input checked="" type="checkbox"/> Wood frame <input type="checkbox"/> Post and beam <input type="checkbox"/> balloon <input type="checkbox"

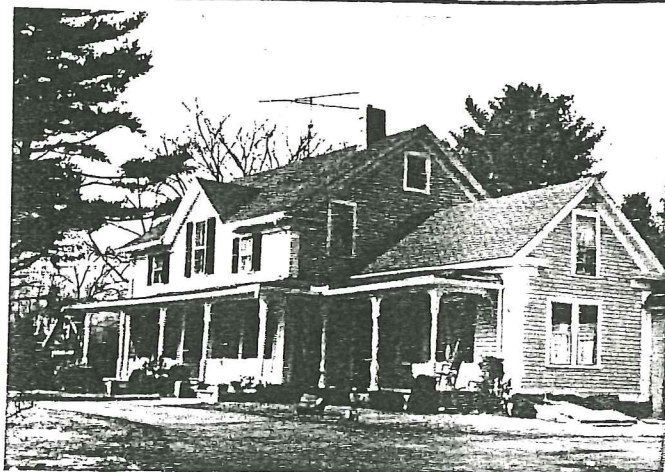
PHOTO	PHOTOGRAPHER Mark McDonough		DATE 1986
	VIEW NW	NEGATIVE ON FILE I22	
COMPILED BY	NAME Mark McDonough		DATE 1986
	ORGANIZATION Town of Thompson, Connecticut		
	ADDRESS

17 OTHER NOTABLE FEATURES OF BUILDING OR SITE (interior and/or exterior)  
 Five-bay facade with central entry. Sash generally 2-over-2. Large entry has double doors with single lights over panels. One story full-width porch has turned posts, large jigsawn post brackets with drilled circles.

Above entry, gabled wall dormer with oversized window flanked by small windows; all three have peaked caps with two rows of offset dentils. Sawtooth and fishscale shingles in dormer peak. Paneled corner pilasters, plain frieze; molded cornice shows partial return. Single brick chimney is offset to the right. Lower parallel right wing has similar detailing, identical porch.
