HISTORIC RESOURCES INVENTORY
BUILDING AND STRUCTURES
 HIST-6 NEW 5/77

1. BUILDING NAME (Common)		(Historic)	
THOMPSON		CHARLES RANDALL HOUSE	
2. TOWN CITY	VILLAGE	COUNTY	
THOMPSON	QUADDICK	WINDHAM	
3. STREET AND NUMBER (and/or location)		143/16-9	
180 QUADDICK ROAD (458 QUADDICK RD.)

CONTINUATION SHEET #19 CHARLES RANDALL HOUSE ✓
Item number: _____ Date: _____

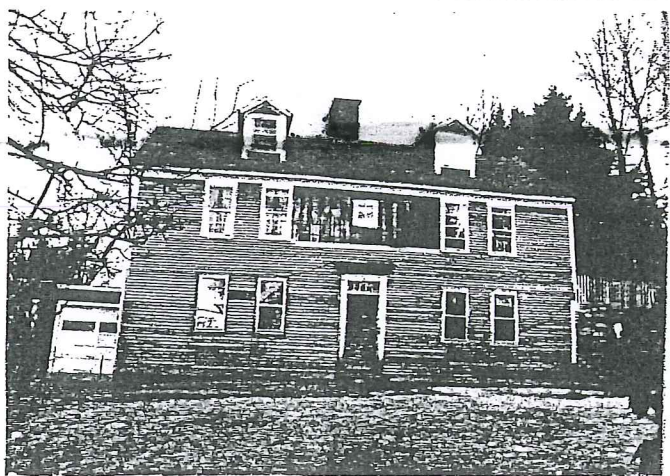
PHOTO	PHOTOGRAPHER		DATE
	Mark McDonough		1986
COMPILED BY	VIEW	NEGATIVE ON FILE	
	N	I24	
	NAME		DATE
	Mark McDonough		1986
ORGANIZATION			
Town of Thompson, Connecticut			
ADDRESS

Five-bay facade, central entry, window bays paired and grouped towards center of house. Entry fabric mostly new. Old paneled wood door, old rectangular transom lights, new transom bar and surround.

Above, old splayed wooden lintel and flat molded cap. Sash generally old 6-over-6, small later four pane window over entry. Second floor windows abut narrow plain frieze. Bed molding. Molded cornice shows partial return.

Central brick chimney. Two gabled roof dormers. At left and right end of facade, entry sized bays were recently boarded over; full width porch recently removed. Side elevations plain; c. 1950 attached garage at left rear.
