HISTORIC RESOURCES INVENTORY
BUILDING AND STRUCTURES
 HIST-6 NEW 5/77

IDENTIFICATION	1. BUILDING NAME (Common) _____ (Historic) JOHN SHERMAN HOUSE	
	2. TOWN CITY THOMPSON	VILLAGE E. THOMPSON
	3. STREET AND NUMBER (and/or location) 237 EAST THOMPSON ROAD (673 EAST THOMPSON RD.) 152/2-1

6. ACCESSIBILITY TO PUBLIC: EXTERIOR VISIBLE FROM PUBLIC ROAD <input checked="" type="checkbox"/> Yes <input type="checkbox"/> No INTERIOR ACCESSIBLE <input type="checkbox"/> Yes <input checked="" type="checkbox"/> No IF YES, EXPLAIN _____	
DESCRIPTION	7. STYLE OF BUILDING Victorian Vernacular	
	DATE OF CONSTRUCTION c. 1865

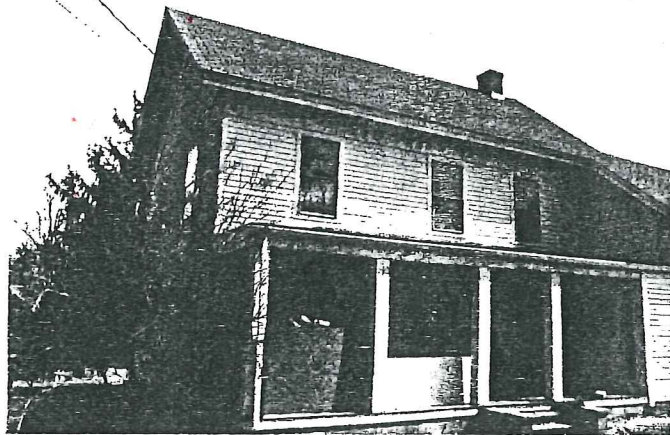
Facade has two bays on first floor, three bays on second, no entry. Central second floor window on left elevation is Palladian with stained glass central sash, diamond pane transom and side sash. Sash generally 6-over-6. Wide plain frieze with large paired jigsaw brackets. Molded cornice.

Right elevation has one story porch on recent square posts. Porch shelters entry: paneled wood door with rectangular sidelights. Roofline extends at right rear corner to form one-and-one-half-story rear wing with similar detailing.

Left elevation has Palladian window similar to facade, else plain.
