**HISTORIC RESOURCES INVENTORY**  
**BUILDING AND STRUCTURES**  
 HIST-6 NEW 5/77

STATE OF CONNECTICUT  
**CONNECTICUT HISTORICAL COMMISSION**  
 59 SOUTH PROSPECT STREET, HARTFORD, CONNECTICUT 06106  
 (203) 566-3005

1. BUILDING NAME (Common)		(Historic)	
2. TOWN CITY	VILLAGE	COUNTY	
THOMPSON	NORTH GROSVENORDALE	WINDHAM	
3. STREET AND NUMBER (and/or location)		167/59-12	
91 Buckley Hill Road (41 Buckley Hill Rd.)

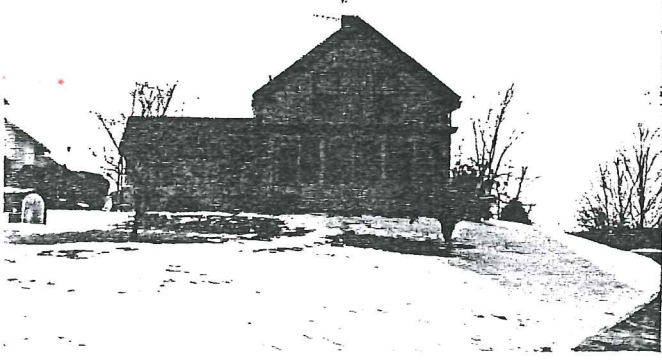
PHOTO	PHOTOGRAPHER Mark McDonough		DATE 1986
	VIEW S	NEGATIVE ON FILE D20	
COMPILED BY	NAME Mark McDonough		DATE 1986
	ORGANIZATION Town of Thompson, Connecticut		
	ADDRESS

11. NUMBER OF STORIES		APPROXIMATE DIMENSIONS	
1 1/2		23' X 28'	
12. CONDITION (Structural)			
<input type="checkbox"/> Excellent <input checked="" type="checkbox"/> Good <input type="checkbox"/> Fair <input type="checkbox"/> Deteriorated <input type="checkbox"/> Excellent <input checked="" type="checkbox"/> Good <input type="checkbox"/> Fair <input type="checkbox"/> Deteriorated

DESCRIPTION (Continued)	17 OTHER NOTABLE FEATURES OF BUILDING OR SITE (interior and/or exterior)	
	<p>Three-bay facade, left entry has wood door with twin round-arched lights. Full-width framed-in one-story porch. Sash generally modern 1-over-1. Molded cornice shows partial return.</p> <p>Left elevation: modern picture window, altered one-and-one-half-story wing at rear.</p>	
SIGNIFICANCE	18 ARCHITECT	BUILDER
	19 HISTORICAL OR ARCHITECTURAL IMPORTANCE	
SOURCES	<p>This simple dwelling was built about 1875 by landowner Obediah Stone, shortly after the completion of the nearby Grosvenor-Dale Company cotton mill (1872). Like several other modest houses near the intersection of Buckley Hill and Elliott roads, this dwelling probably housed workers at the mill or at the nearby Elliott Wagon Factory.</p> <p>Historically, the building is significant as part of a large and relatively well-preserved assemblage of 19th-century buildings in this former cotton mill settlement (the mills were closed in 1954).</p> <p>Architecturally, it is highly altered, but retains its original Victorian doors and gable-and-wing massing.</p>
