HISTORIC RESOURCES INVENTORY
BUILDING AND STRUCTURES
 HIST-6 NEW 5/77

IDENTIFICATION	1. BUILDING NAME (Common) (Historic)		ANDREW WILBUR TENEMENT		
	2. TOWN CITY THOMPSON		VILLAGE NORTH GROSVENORDALE	COUNTY WINDHAM	
	3. STREET AND NUMBER (and/or location) 1170 ROUTE 12 (901 RIVERSIDE DR.)		167/59-5

7. STYLE OF BUILDING Mill Housing		DATE OF CONSTRUCTION c. 1897		
	8. MATERIAL(S) (Indicate use or location when appropriate)				
	<input checked="" type="checkbox"/> Clapboard <input type="checkbox"/> Asbestos Siding <input checked="" type="checkbox"/> Chimneys <input type="checkbox"/> Other (Specify) _____ <input type="checkbox"/> Wood Shingle <input type="checkbox"/> Asphalt Siding <input type="checkbox"/> Brick <input type="checkbox"/> Fieldstone <input type="checkbox"/> Board & Batten <input type="checkbox"/> Stucco <input type="checkbox"/> Cobblestone <input type="checkbox"/> Aluminum Siding <input type="checkbox"/> Concrete Type: _____ <input type="checkbox"/> Cut stone Type: _____				
	DESCRIPTION	9. STRUCTURAL SYSTEM			
<input checked="" type="checkbox"/> Wood frame <input type="checkbox"/> Post and beam <input type="checkbox"/> balloon <input type="checkbox"/> Load bearing ma

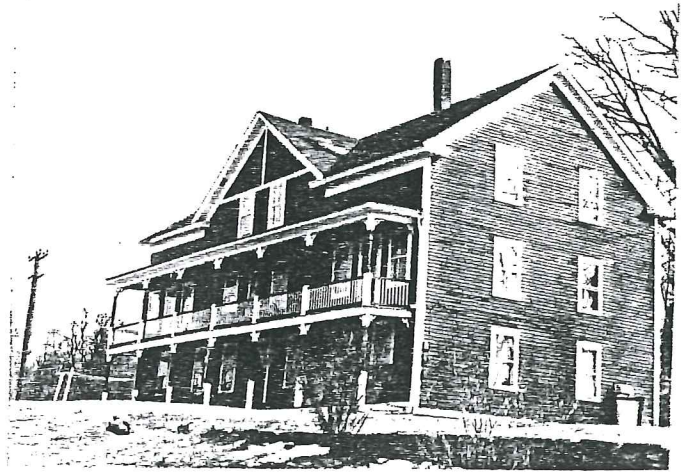
PHOTO	PHOTOGRAPHER Mark McDonough		DATE 1986
	VIEW NE	NEGATIVE ON FILE A29	
COMPILED BY	NAME Mark McDonough		DATE 1986
	ORGANIZATION Town of Thompson, Connecticut		
	ADDRESS

11. NUMBER OF STORIES 2 1/2		APPROXIMATE DIMENSIONS 56' x 30'			
12. CONDITION (Structural) (Exterior)					
<input type="checkbox"/> Excellent <input checked="" type="checkbox"/> Good <input type="checkbox"/> Fair <input type="checkbox"/> Deteriorated <input type="checkbox"/> Excellent <input checked="" type="checkbox"/> Good <input type="checkbox"/> Fair <input type="checkbox"/> Deteriorated

Six bays, entry in fourth. Sash generally 2-over-2. Two story full width porch has turned posts, jigsaw brackets, plain frieze. No railing on first, square balusters, molded rail on second. Large central gabled wall dormer with diagonal clapboard panels in peak. Plain corner boards and frieze. Molded cornice shows partial return.

Twin brick chimneys. Rear elevation (upslope) is one-and-one-half-story, with frieze band windows, central entry in glassed-in portico.
