**HISTORIC RESOURCES INVENTORY**  
**BUILDING AND STRUCTURES**  
 HIST-6 NEW 5/77

IDENTIFICATION	1. BUILDING NAME (Common) _____ (Historic)	
	2. TOWN CITY THOMPSON	VILLAGE NORTH GROSVENORDALE
	3. STREET AND NUMBER (and/or location) 73 BUCKLEY HILL ROAD (35 Buckley Hill Rd.)

7. STYLE OF BUILDING Mill Housing	
	DATE OF CONSTRUCTION c. 1890	
	8. MATERIAL(S) (Indicate use or location when appropriate)	
	<input type="checkbox"/> Clapboard <input type="checkbox"/> Asbestos Siding <input checked="" type="checkbox"/> Brick <input type="checkbox"/> Chimneys <input type="checkbox"/> Other (Specify) _____ <input type="checkbox"/> Wood Shingle <input checked="" type="checkbox"/> Asphalt Siding <input checked="" type="checkbox"/> Fieldstone <input type="checkbox"/> Foundation <input type="checkbox"/> Board & Batten <input type="checkbox"/> Stucco <input type="checkbox"/> Cobblestone <input type="checkbox"/> Aluminum Siding <input type="checkbox"/> Concrete Type: _____ <input type="checkbox"/> Cut stone Type: _____	
DESCRIPTION	9. STRUCTURAL SYSTEM	
	<input checked="" type="checkbox"/> Wood frame <input type="checkbox"/> Post and beam <input type="checkbox"/> balloon <input type="checkbox"/> L

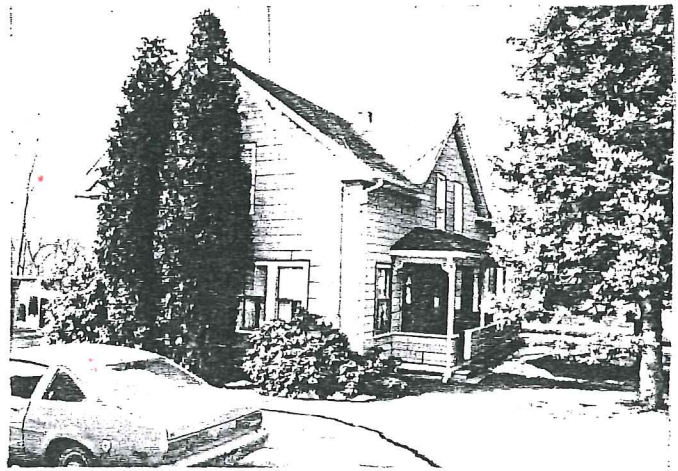
PHOTO	PHOTOGRAPHER Mark McDonough		DATE 1986
	VIEW W	NEGATIVE ON FILE D16	
COMPILED BY	NAME Mark McDonough		DATE 1986
	ORGANIZATION Town of Thompson, CT		
	ADDRESS

11. NUMBER OF STORIES 1 1/2	APPROXIMATE DIMENSIONS 44' x 28'
	12. CONDITION (Structural) _____ (Exterior)	
	<input type="checkbox"/> Excellent <input checked="" type="checkbox"/> Good <input type="checkbox"/> Fair <input type="checkbox"/> Deteriorated <input type="checkbox"/> Excellent <input checked="" type="checkbox"/> Good <input type="checkbox"/> Fair <input type="checkbox"/> Deteriorated

13. INTEGRITY (Location) <input checked="" type="checkbox"/> On original site <input type="checkbox"/> Moved	WHEN? _____ (Alterations) <input checked="" type="checkbox"/> Yes <input type="checkbox"/> No IF YES, EXPLAIN Siding later

Six-bay facade, entries in second and fifth. Doors have single large pane over rectangular panels with deeply molded edges. Sash generally 2-over-2. One story porch, nearly full width. Sided railing, square chamfered posts, quarter-circle post brackets with radial cut-outs.

Sawtooth valence, plain frieze. Central gabled wall dormer with paired windows. Molded cornice shows partial return.
