HISTORIC RESOURCES INVENTORY
BUILDING AND STRUCTURES

IDENTIFICATION	1. BUILDING NAME (Common) _____ (Historic) _____	
	2. TOWN CITY THOMPSON	VILLAGE NORTH GROSVENORDALE
	3. STREET AND NUMBER (and/or location) 1083 ROUTE 12 (944 RIVERSIDE DR.) 167/88-27

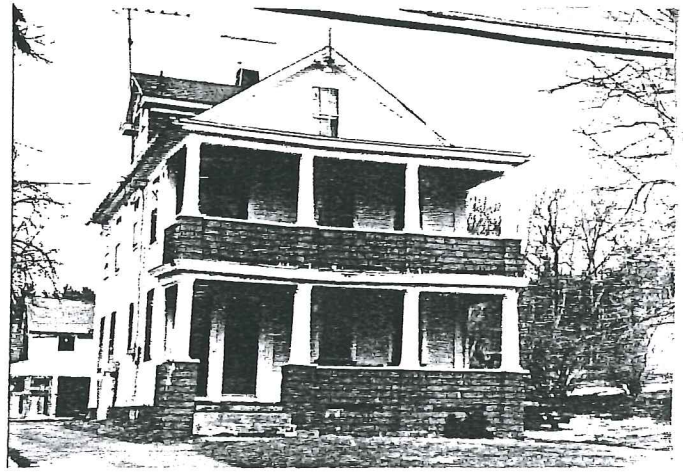
PHOTO	PHOTOGRAPHER Mark McDonough	DATE 1986
	VIEW W	NEGATIVE ON FILE A34
COMPILED BY	NAME Mark McDonough	DATE 1986
	ORGANIZATION Town of Thompson, Connecticut	
	ADDRESS

Three-bay facade, paired left entires with paneled surround, corner blocks with incised bosses. Two-story porch (c. 1915) on tapered square posts with shingled railing and piers, plain frieze. Sash generally old 6-over-6 sash. Left elevation has large gabled roof dormer. Right has lower parallel extension, attached barn-shed at rear.
