HISTORIC RESOURCES INVENTORY
BUILDING AND STRUCTURES
 HIST-6 NEW 5/77

IDENTIFICATION	1. BUILDING NAME (Common) (Historic)		HORACE WALKER FARM	
	2. TOWN CITY		VILLAGE	COUNTY
	THOMPSON		NORTH GROSVENORDALE	WINDHAM
	3. STREET AND NUMBER (and/or location)		169/88-64	
	81 MAIN STREET (78 MAIN ST.)

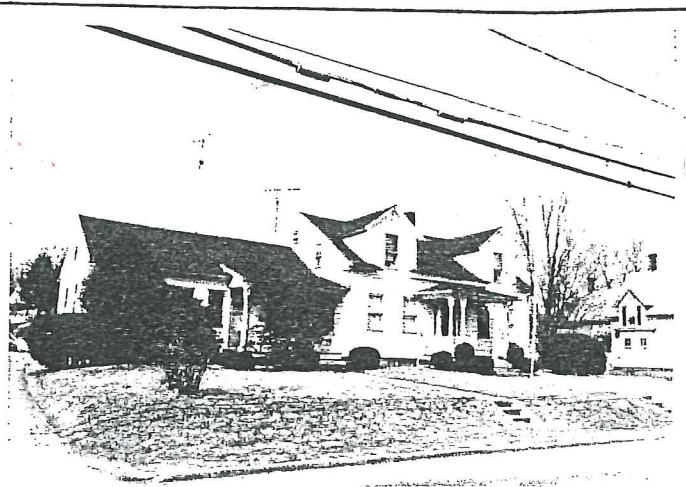
PHOTO	PHOTOGRAPHER Mark McDonough		DATE 1986
	VIEW NW	NEGATIVE ON FILE C9	
COMPILED BY	NAME Mark McDonough		DATE 1986
	ORGANIZATION Town of Thompson, Connecticut		
	ADDRESS

Five-bay main wing with central entry. Hip-roofed entry portico with square balusters, turned posts, jigsaw brackets. Door has single large light over panels; paneled entry surround with paneled corner blocks. Two large gabled wall dormers. Sash generally left wing has entry with small shed-roofed portico on turned posts. To rear, cross-gabled shed/barn extensions.

Architecturally, the Walker House is significant as a good, if somewhat altered example of a 19th-century vernacular dwelling with classically-inspired Greek Revival detailing (seen in the paneled entry surround). The dormers and porticoes are later alterations. The attached agricultural buildings are a relatively common feature in 19th-century farm houses.
