HISTORIC RESOURCES INVENTORY
BUILDING AND STRUCTURES
 HIST-6 NEW 5/77

IDENTIFICATION	1. BUILDING NAME (Common) (Historic)		JESSE TUCKER HOUSE	
	2. TOWN CITY		VILLAGE	COUNTY
	THOMPSON		NORTH GROSVENORDALE	WINDHAM
	3. STREET AND NUMBER (and/or location)			
	159 MAIN STREET (40 MAIN ST.)

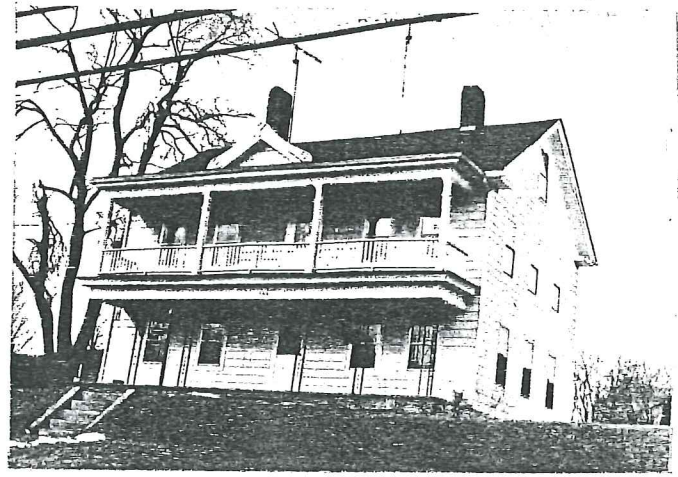
PHOTO	PHOTOGRAPHER Mark McDonough		DATE 1986
	VIEW SW	NEGATIVE ON FILE A7	
COMPILED BY	NAME Mark McDonough		DATE 1986
	ORGANIZATION Town of Thomposn, Connecticut		
	ADDRESS

11. NUMBER OF STORIES		APPROXIMATE DIMENSIONS		
2 1/2		36' X 26'		
12. CONDITION (Structural)		(Exterior)		
<input type="checkbox"/> Excellent	<input checked="" type="checkbox"/> Good	<input type="checkbox"/> Fair	<input type="checkbox"/> Deteriorated	
<input type="checkbox"/> Excellent	<input checked="" type="checkbox"/> Good	<input type="checkbox"/> Fair	<input type="checkbox"/> Deteriorated

Five-bay, central entry. Sash generally 2-over-2. Two-story flat-roofed porch has steel "wroughtiron" supports and no railing on first floor. Second floor has slat railing, molded rail, tapered square chamfered columns after Tuscan. Blind gabled dormer on porch has decorative panel resembling werge board with applied wooden decorations in arrow and scroll motifs.

Architecturally, the building is rather plain and much-altered (the porch is an early 20th-century alterations with later modifications). The decorative panel on the central dormer is a typical late 19th century feature. Many buildings of the time display decorative woodwork made affordable by mid-century improvements in wood-forming technology.
