HISTORIC RESOURCES INVENTORY
BUILDING AND STRUCTURES

1. BUILDING NAME (Common)		(Historic)	
THOMPSON		ASA UPHAM HOUSE	
2. TOWN CITY	VILLAGE	COUNTY	
THOMPSON	NORTH GROSVENORDALE	WINDHAM	
3. STREET AND NUMBER (and/or location)			
222 MAIN STREET DEMOLISHED - 1988 0 MAIN ST 169/91-33			
4. OWNER(S)			
MOONEY, ROBERT E. & LORRAINE M., 545 RAMSHORN RD, DUDLEY, MA 01570 <input type="checkbox"/> Public <input checked="" type="checkbox"/> Private			
5. USE (Present)			
Residence (Historic)			
6. ACCESSIBILITY TO PUBLIC:		IF YES, EXPLAIN	
EXTERIOR VISIBLE FROM PUBLIC ROAD		INTERIOR ACCESSIBLE	
<input checked="" type="checkbox"/> Yes <input type="checkbox"/> No		<input type="checkbox"/> Yes <input checked="" type="checkbox"/> No

CONTINUATION SHEET #19 ASA UPHAM HOUSE
 Item number: _____ Date: _____

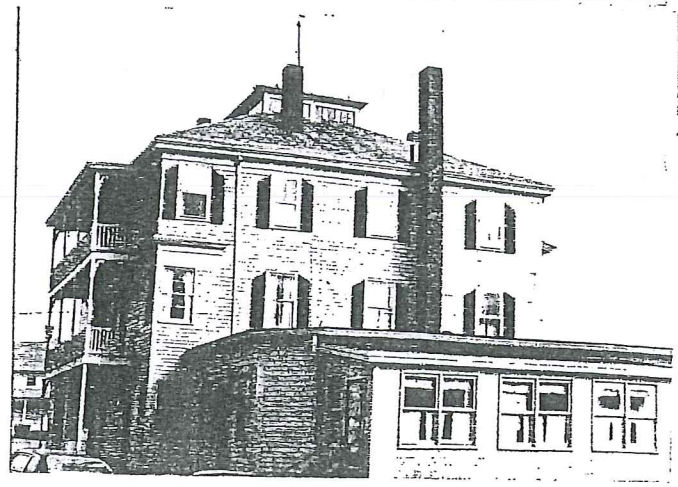
PHOTO	PHOTOGRAPHER	DATE
	Mark McDonough	1986
COMPILED BY	VIEW	NEGATIVE ON FILE
	NW	A17
	NAME	DATE
	Mark McDonough	1986
	ORGANIZATION	
	Town of Thompson, Connecticut	
	ADDRESS

11. NUMBER OF STORIES		APPROXIMATE DIMENSIONS	
3 1/2		40' x 40'	
12. CONDITION (structural) (exterior)			
<input type="checkbox"/> Excellent	<input checked="" type="checkbox"/> Good	<input type="checkbox"/> Fair	<input type="checkbox"/> Deteriorated
<input type="checkbox"/> Excellent	<input type="checkbox"/> Good	<input checked="" type="checkbox"/> Fair	<input type="checkbox"/> Deteriorated

13. INTEGRITY (Location)			
<input checked="" type="checkbox"/> On original site	<input type="checkbox"/> Moved	WHEN?	(Alterations) IF YES, EXPLAIN
<input checked="" type="checkbox"/> On original site	<input type="checkbox"/> Moved		<input checked="" type="checkbox"/> Yes <input type="checkbox"/> No New siding; c. 1890 porch

17 OTHER NOTABLE FEATURES OF BUILDING OR SITE (interior and/or exterior)
 Five-bay facade, central entry. Sash generally 2-over-2. Wood door has twin rectangular lights, deeply molded panels, glazed transom. Three story three-bay front porch has turned posts, jigsaw brackets, molded rail, square baluster.
 Cupola atop hip roof. One story flat roofed wing at right.

Architecturally, the Upham House is extensively altered, but the cupola and late Victorian porch are interesting features.
