HISTORIC RESOURCES INVENTORY
BUILDING AND STRUCTURES
 HIST-6 NEW 5/77

IDENTIFICATION	1. BUILDING NAME (Common) (Historic) THE PERRY HOUSE	
	2. TOWN CITY THOMPSON	VILLAGE FABYAN
	3. STREET AND NUMBER (and/or location) 134 FABYAN-WOODSTOCK ROAD & PARKER ROAD (611 FABYAN RD.) 17/83-5

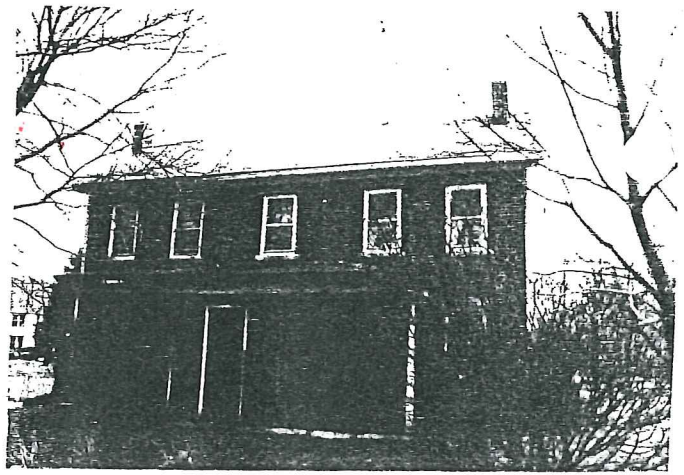
PHOTO	PHOTOGRAPHER Mark McDonough	DATE 1986
	VIEW NE	NEGATIVE ON FILE H2
COMPILED BY	NAME Mark McDonough	DATE 1986
	ORGANIZATION Town of Thompson, Connecticut	
	ADDRESS

11. NUMBER OF STORIES APPROXIMATE DIMENSIONS 2 1/2 36' x 26'	
	12. CONDITION (Structural) (Exterior) <input type="checkbox"/> Excellent <input checked="" type="checkbox"/> Good <input type="checkbox"/> Fair <input type="checkbox"/> Deteriorated <input type="checkbox"/> Excellent <input checked="" type="checkbox"/> Good <input type="checkbox"/> Fair <input type="checkbox"/> Deteriorated

13. INTEGRITY (Location) WHEN? (Alterations) IF YES, EXPLAIN <input checked="" type="checkbox"/> On original site <input type="checkbox"/> Moved <input checked="" type="checkbox"/> Yes <input type="checkbox"/> No Some later sash, cinder block chimney

Five-bay facade, central entry. Sash generally 2-over-2, heavy granite sills and lintels. Brick walls laid up in common bond with occasional header courses. Entry has old batten door, large rectangular sidelights with three rows of panes.

One story screened-in Tuscan columned porch (c. 1910) with square balusters, molded rail. Second floor windows relatively high under eaves, window bays paired and offset towards corners of house. Molded cornice shows partial return. New exterior concrete block chimney at left, brick chimney at right.
