HISTORIC RESOURCES INVENTORY
BUILDING AND STRUCTURES
 HIST-6 NEW 5/77

17/84/30/1

IDENTIFICATION	1. BUILDING NAME (Common) _____ (Historic) NEW BOSTON MILLOWNER'S RESIDENCE	
	2. TOWN CITY THOMPSON	VILLAGE COUNTY FABYAN WINDHAM
	3. STREET AND NUMBER (and/or location) 210 FABYAN-WOODSTOCK ROAD (575 FABYAN RD.) 17/84-30

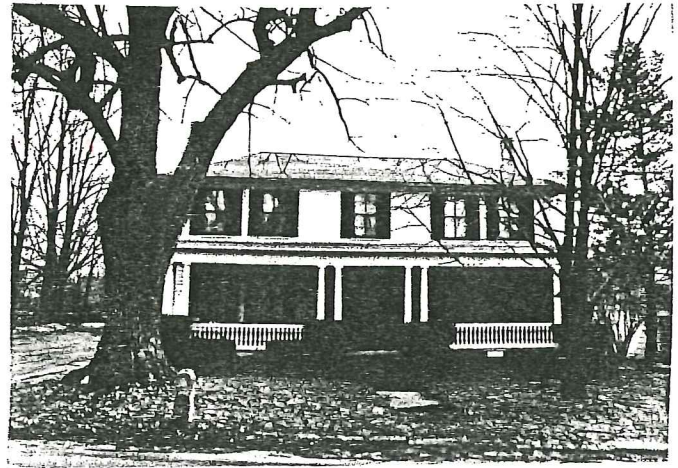
PHOTO	PHOTOGRAPHER Mark McDonough		DATE 1986
	VIEW E	NEGATIVE ON FILE H10	
COMPILED BY	NAME Mark McDonough		DATE 1986
	ORGANIZATION Town of Thompson, Connecticut		
	ADDRESS

Five-bay facade, central entry, window bays paired and offset towards corners of building. Sash generally 2-over-2, second floor windows located high under eaves.

First floor windows have peaked, molded caps. Entry has double wood doors with single large lights over panels. One story screened-in porch on paired Tuscan columns. Turned balusters, molded rail, plain frieze, denticular molded cornice. Twin brick chimneys on hip roof.
