**HISTORIC RESOURCES INVENTORY**  
**BUILDING AND STRUCTURES**  
 HIST-6 NEW 5/77

1. BUILDING NAME (Common) _____ (Historic)	
2. TOWN CITY THOMPSON	COUNTY WINDHAM
3. STREET AND NUMBER (and/or location) 262 HAGSTROM ROAD	19/85-8
4. OWNER(S) BURTON, ALLAN & SYLVIA S., HAGSTROM ROAD, WOODSTOCK, CT <input type="checkbox"/> Public <input checked="" type="checkbox"/> Private	
5. USE (Present) _____ (Historic) Residence	
6. ACCESSIBILITY TO PUBLIC: <input checked="" type="checkbox"/> Yes <input type="checkbox"/> No	INTERIOR ACCESSIBLE <input type="checkbox"/> Yes <input checked="" type="checkbox"/> No

7. STYLE OF BUILDING Greek Revival, Vernacular		DATE OF CONSTRUCTION c. 1850 (remodelled)
8. MATERIAL(S) (Indicate use or location when appropriate)		
<input checked="" type="checkbox"/> Clapboard	<input type="checkbox"/> Asbestos Siding	<input checked="" type="checkbox"/> Chimney Brick <input type="checkbox"/> Other (Specify) _____
<input type="checkbox"/> Wood Shingle	<input type="checkbox"/> Asphalt Siding	<input type="checkbox"/> Fieldstone
<input type="checkbox"/> Board & Batten	<input type="checkbox"/> Stucco	<input type="checkbox"/> Cobblestone
<input type="checkbox"/> Aluminum Sidi

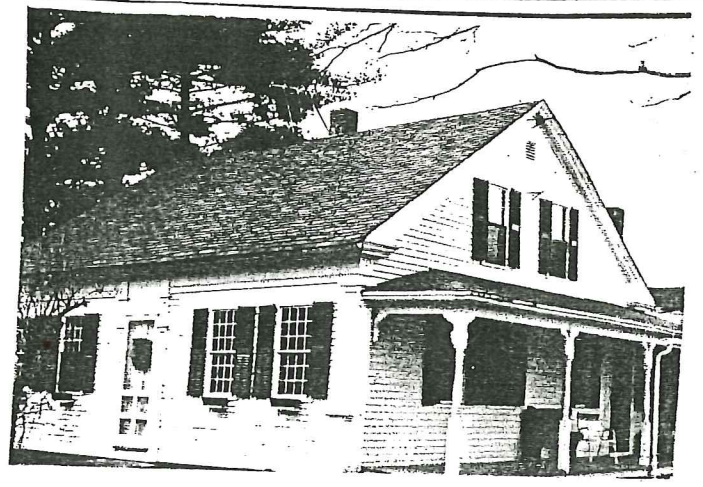
PHOTO	PHOTOGRAPHER Mark McDonough		DATE 1986
	VIEW NW	NEGATIVE ON FILE K29	
COMPILED BY	NAME Mark McDonough		DATE 1986
	ORGANIZATION Town of Thompson, Connecticut		
	ADDRESS

11. NUMBER OF STORIES 1 1/2	APPROXIMATE DIMENSIONS 31' x 30' (front portion)	
12. CONDITION (Structural) _____ (Exterior) _____		
<input type="checkbox"/> Excellent <input checked="" type="checkbox"/> Good <input type="checkbox"/> Fair <input type="checkbox"/> Deteriorated	<input type="checkbox"/> Excellent <input checked="" type="checkbox"/> Good <input type="checkbox"/> Fair <input type="checkbox"/> Deteriorated

13. INTEGRITY (Location) _____ WHEN? _____ (Alterations) _____ IF YES, EXPLAIN		
<input checked="" type="checkbox"/> On original site <input type="checkbox"/> Moved	<input checked="" type="checkbox"/> Yes <input type="checkbox"/> No	Later sash

Five-bay facade, central entry. Sash generally recent 12-over-12. Heavy paneled door, paneled entry pilasters extend to eaves. Paneled corner pilasters. Wide plain frieze; molded cornice shows partial return. Right elevation has c. 1890 on turned posts. Parallel right rear wing with old 6-over-6 sash.
