**HISTORIC RESOURCES INVENTORY**  
**BUILDING AND STRUCTURES**  
 HIST-6 NEW 5/77

1. BUILDING NAME (Common)		(Historic)	
2. TOWN CITY THOMPSON	VILLAGE	COUNTY WINDHAM	
3. STREET AND NUMBER (and/or location) 212 HAGSTROM ROAD		(106 HAGSTROM RD.) 19/85-9

7. STYLE OF BUILDING Greek Revival		DATE OF CONSTRUCTION c. 1850	
8. MATERIAL(S) (Indicate use or location when appropriate)			
<input checked="" type="checkbox"/> Clapboard <input type="checkbox"/> Asbestos Siding <input checked="" type="checkbox"/> Chimney <input type="checkbox"/> Other (Specify) _____ <input type="checkbox"/> Wood Shingle <input type="checkbox"/> Asphalt Siding <input checked="" type="checkbox"/> Fieldstone Foundation <input type="checkbox"/> Board & Batten <input type="checkbox"/> Stucco <input type="checkbox"/> Cobblestone <input type="checkbox"/> Aluminum Siding <input type="checkbox"/> Concrete Type: _____ <input type="checkbox"/> Cut stone Type: _____

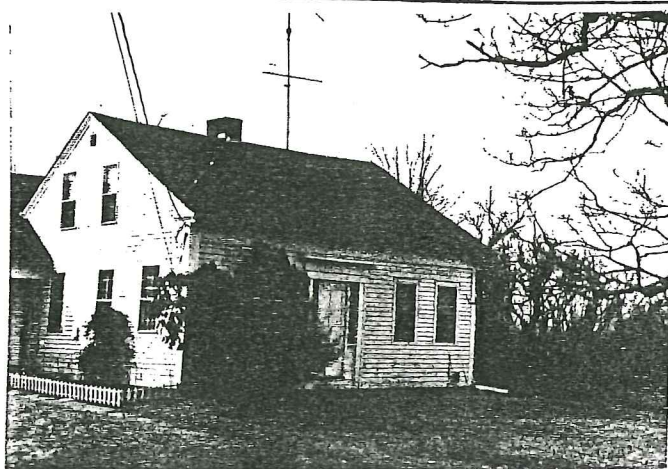
PHOTO	PHOTOGRAPHER Mark McDonough		DATE 1986
	VIEW N	NEGATIVE ON FILE K27	
COMPILED BY	NAME Mark McDonough		DATE 1986
	ORGANIZATION Town of Thompson, Connecticut		
	ADDRESS

11. NUMBER OF STORIES 1 1/2		APPROXIMATE DIMENSIONS 29' x 25' (front); 37' x 13' (rear)	
12. CONDITION (Structural) (Exterior)			
<input type="checkbox"/> Excellent <input type="checkbox"/> Good <input checked="" type="checkbox"/> Fair <input type="checkbox"/> Deteriorated <input type="checkbox"/> Excellent <input type="checkbox"/> Good <input type="checkbox"/> Fair <input checked="" type="checkbox"/> Deteriorated

DESCRIPTION (Continued)	17 OTHER NOTABLE FEATURES OF BUILDING OR SITE (interior and/or exterior)
	<p>Five-bay facade, central entry with sidelights, paneled pilasters. Heavy paneled wood door. Wide frieze, flat molded cap above entry. Plain corner pilasters, molded window surrounds.</p> <p>Lower parallel left wing. Sash mixed. Wide plain corner pilasters and frieze; molded cornice shows partial return.</p>
