HISTORIC RESOURCES INVENTORY
BUILDINGS AND STRUCTURES
 HIST-6 NEW 5/77

IDENTIFICATION	1. BUILDING NAME (Common) _____ (Historic) _____	
	2. TOWN CITY THOMPSON	VILLAGE N. GROSVENORDALE
	3. STREET AND NUMBER (and/or location) 699 RAVENELLE ROAD (350 RAVENELLE RD.) 46/104-89M

7. STYLE OF BUILDING Vernacular	
	DATE OF CONSTRUCTION c. 1880	
	8. MATERIAL(S) (Indicate use or location when appropriate)	
	<input checked="" type="checkbox"/> Clapboard <input type="checkbox"/> Asbestos Siding <input checked="" type="checkbox"/> Chimneys <input type="checkbox"/> Other (Specify) _____ <input type="checkbox"/> Wood Shingle <input type="checkbox"/> Asphalt Siding <input type="checkbox"/> Brick <input type="checkbox"/> Fieldstone <input type="checkbox"/> Board & Batten <input type="checkbox"/> Stucco <input type="checkbox"/> Cobblestone <input type="checkbox"/> Aluminum Siding <input type="checkbox"/> Concrete Type: _____ <input type="checkbox"/> Cut stone Type: _____	
DESCRIPTION	9. STRUCTURAL SYSTEM	
	<input checked="" type="checkbox"/> Wood frame <input type="checkbox"/> Post and beam <input type="checkbox"/> balloon <input type="checkbox"/> Load bearing masonry <input type="checkbox"/> Struc

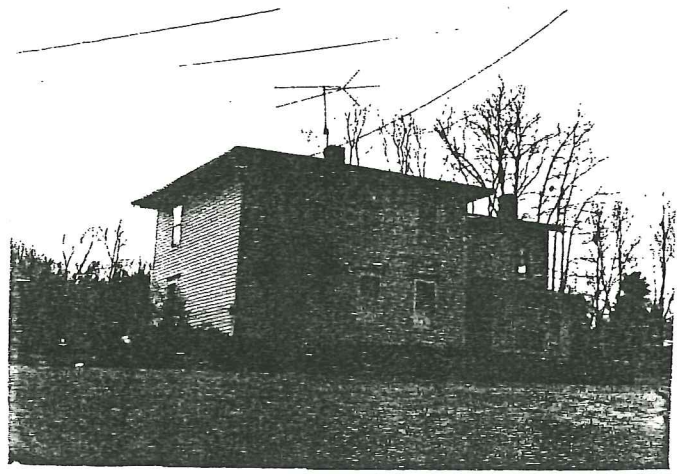
PHOTO	PHOTOGRAPHER Mark McDonough		DATE 1986
	VIEW NW	NEGATIVE ON FILE K20	
COMPILED BY	NAME Mark McDonough		DATE 1986
	ORGANIZATION Town of Thompson, Connecticut		
	ADDRESS		
SUBSEQUENT FIELD EVALUATION

11. NUMBER OF STORIES 2	APPROXIMATE DIMENSIONS 39' x 22'
	12. CONDITION (Structural) _____ (Exterior) _____	
	<input type="checkbox"/> Excellent <input checked="" type="checkbox"/> Good <input type="checkbox"/> Fair <input type="checkbox"/> Deteriorated <input type="checkbox"/> Excellent <input checked="" type="checkbox"/> Good <input type="checkbox"/> Fair <input type="checkbox"/> Deteriorated

13. INTEGRITY (Location) <input type="checkbox"/> On original site <input checked="" type="checkbox"/> Moved	WHEN? 1966 (Alterations) <input checked="" type="checkbox"/> Yes <input type="checkbox"/> No IF YES, EXPLAIN Some new sash

Three-bay facade, left entry under braced, open gabled hood on large chamfered brackets with turned bosses and pendants. Original door has twin round arched panels.

Right bays grouped slightly. Some old 2-over-2 sash; first floor windows have flat molded caps. Overhanging eaves, molded cornice. Two story gabled wing to right has framed-in porch.
