**HISTORIC RESOURCES INVENTORY**  
**BUILDING AND STRUCTURES**

IDENTIFICATION	1. BUILDING NAME (Common) <span style="float: right;">(Historic)</span> RAMSDELL HOUSE	
	2. TOWN CITY THOMPSON	VILLAGE WEST THOMPSON
	3. STREET AND NUMBER (and/or location) RAVENELL ROAD 48/104-83B

#19 RAMSDELL HOUSE

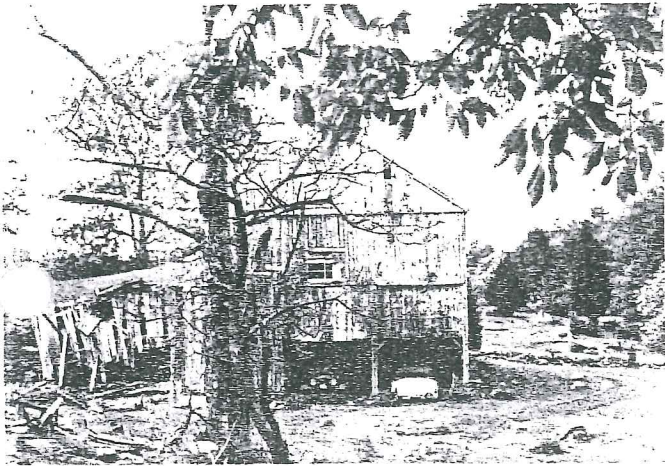
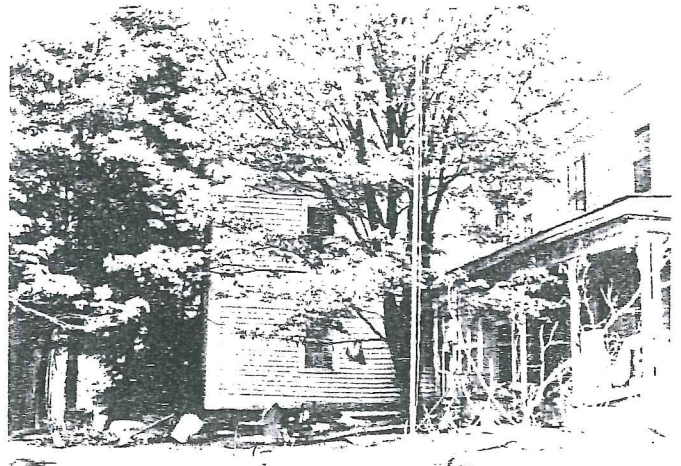
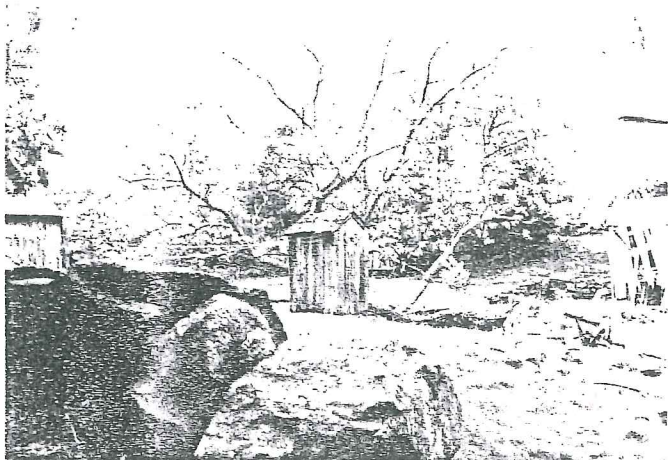
Architecturally, it is significant as the single best preserved farmstead in Thompson. The series of connected buildings, each built in a different style, adds to the architectural value of the site. The brick endwalls of the central portion are a locally popular feature.
