HISTORIC RESOURCES INVENTORY
BUILDING AND STRUCTURES
 HIST-6 NEW 5 77

IDENTIFICATION	1. BUILDING NAME (Common)		(Historic)	
	THOMPSON		RIEL CONVERSE HOUSE	
	2. TOWN CITY	VILLAGE	COUNTY	
	THOMPSON	WILSONVILLE	WINDHAM	
	3. STREET AND NUMBER (and/or location)			
	211 ROUTE 12		(1448 RIVERSIDE DR.)	
	55/65-17

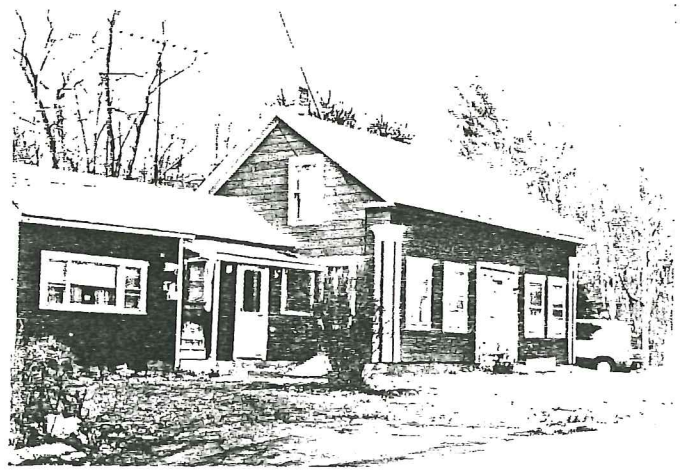
PHOTO	PHOTOGRAPHER	DATE
	Mark McDonough	1986
COMPILED BY	VIEW	NEGATIVE ON FILE
	NW	F7
	NAME	DATE
Mark McDonough	1986	
ORGANIZATION		
Town of Thompson, Connecticut		
ADDRESS

11. NUMBER OF STORIES		APPROXIMATE DIMENSIONS		
1 1/2		32' x 23'		
12. CONDITION (Structural)				
<input type="checkbox"/> Excellent	<input checked="" type="checkbox"/> Good	<input type="checkbox"/> Fair	<input type="checkbox"/> Deteriorated	
		(Exterior) <input type="checkbox"/> Excellent <input checked="" type="checkbox"/> Good <input type="checkbox"/> Fair <input type="checkbox"/> Deteriorated

13. INTEGRITY (Location)				
<input checked="" type="checkbox"/> On original site	<input type="checkbox"/> Moved	WHEN?	(Alterations) <input checked="" type="checkbox"/> Yes <input type="checkbox"/> No	
IF YES, EXPLAIN				
Later siding, frieze missing, altered fenestration

Five-bay facade, central entry, old heavy paneled door with single large light. Paneled entry surround. Paneled corner pilasters, frieze missing; molded cornice shows partial return. Sash generally old 6-over-6. Lower parallel left wing is old but highly altered.
