HISTORIC RESOURCES INVENTORY
BUILDING AND STRUCTURES
 HIST-6 NEW 5. 77

1. BUILDING NAME (Common)		(Historic)	
WILSONVILLE MILL HOUSING			
2. TOWN CITY	VILLAGE	COUNTY	
THOMPSON	WILSONVILLE	WINDHAM	
3. STREET AND NUMBER (and/or location)			
297 ROUTE 12 (1394 RIVERSIDE DR.)			57/65-20

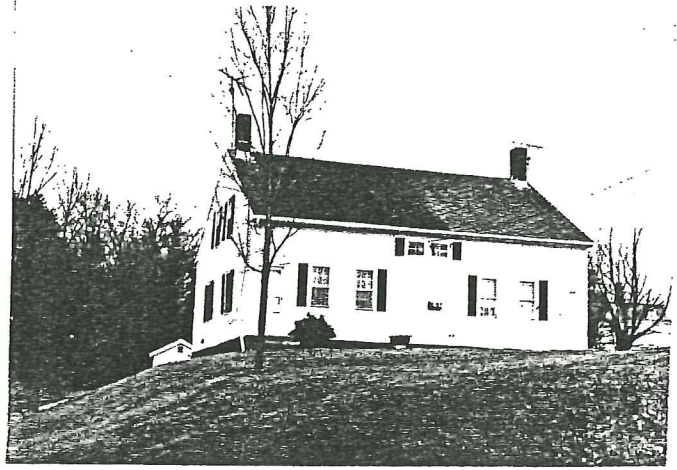
PHOTO	PHOTOGRAPHER Mark McDonough		DATE 1986
	VIEW NE	NEGATIVE ON FILE F9	
COMPILED BY	NAME Mark McDonough		DATE 1986
	ORGANIZATION Town of Thompson		
	ADDRESS

11. NUMBER OF STORIES		APPROXIMATE DIMENSIONS	
1 1/2		41' x 31'	
12. CONDITION (Structural)			
<input type="checkbox"/> Excellent	<input checked="" type="checkbox"/> Good	<input type="checkbox"/> Fair	<input type="checkbox"/> Deteriorated
<input type="checkbox"/> Excellent	<input checked="" type="checkbox"/> Good	<input type="checkbox"/> Fair	<input type="checkbox"/> Deteriorated

13. INTEGRITY (Location)		WHEN?	(Alterations)
<input checked="" type="checkbox"/> On original site	<input type="checkbox"/> Moved		<input checked="" type="checkbox"/> Yes <input type="checkbox"/> No
IF YES, EXPLAIN			
new doors, sash

Eight-bay facade, entries in first and eighth. Windows have splayed brick lintels, old 6-over-6. Bays four and five have small four-pane frieze-band windows. Twin brick chimneys at endwalls. Plain cornice, partial return. Side elevations are plain.
