STATE OF CONNECTICUT
 CONNECTICUT HISTORICAL COMMISSION
 59 SOUTH PROSPECT STREET, HARTFORD, CONNECTICUT 06106
 (203) 566-3005

IDENTIFICATION	1. BUILDING NAME (Common) _____ (Historic) _____	
	2. TOWN CITY THOMPSON	VILLAGE _____ COUNTY WINDHAM
	3. STREET AND NUMBER (and/or location) 596 CORTISS ROAD (59 Cortiss Rd.) 59/67-15

7. STYLE OF BUILDING Vernacular DATE OF CONSTRUCTION c. 1920	
	8. MATERIAL(S) (Indicate use or location when appropriate) <input type="checkbox"/> Clapboard <input type="checkbox"/> Asbestos Siding <input checked="" type="checkbox"/> Brick <input checked="" type="checkbox"/> Other (Specify) Vinyl siding <input type="checkbox"/> Wood Shingle <input type="checkbox"/> Asphalt Siding <input type="checkbox"/> Fieldstone <input type="checkbox"/> Board & Batten <input type="checkbox"/> Stucco <input type="checkbox"/> Cobblestone <input type="checkbox"/> Aluminum Siding <input type="checkbox"/> Concrete Type: _____ <input checked="" type="checkbox"/> Cut stone Type: Random - ashlor granite

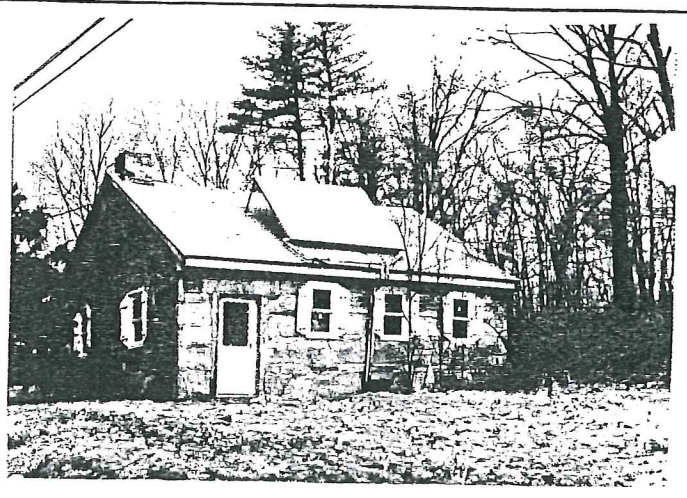
PHOTO	PHOTOGRAPHER Mark McDonough		DATE 1986
	VIEW NE	NEGATIVE ON FILE H34	
COMPILED BY	NAME Mark McDonough		DATE 1986
	ORGANIZATION Town of Thompson, Connecticut		
	ADDRESS

11. NUMBER OF STORIES 1 1/2 APPROXIMATE DIMENSIONS 24' x 26'		
12. CONDITION (Structural) _____ (Exterior) _____ <input type="checkbox"/> Excellent <input checked="" type="checkbox"/> Good <input type="checkbox"/> Fair <input type="checkbox"/> Deteriorated <input type="checkbox"/> Excellent <input checked="" type="checkbox"/> Good <input type="checkbox"/> Fair <input type="checkbox"/> Deteriorated

13. INTEGRITY (Location) _____ WHEN ? _____ (Alterations) _____ IF YES, EXPLAIN _____ <input checked="" type="checkbox"/> On original site <input type="checkbox"/> Moved <input checked="" type="checkbox"/> Yes <input type="checkbox"/> No North frame wing, solar panels

Four-bay facade, entry in first bay. Wooden door with small panes. Sash generally 1-over-1. Random ashlar masonry walls with some very large stones. Massive masonry entry lintel. Stone chimney straddles ridge at left. Wood frame rear addition, c. 1970.
