**HISTORIC RESOURCES INVENTORY**  
**BUILDING AND STRUCTURES**  
 HIST-6 NEW 5.77

1. BUILDING NAME (Common)		(Historic)	
THOMPSON		MARCUS CHILD HOUSE	
2. TOWN CITY	VILLAGE	COUNTY	
THOMPSON	WILSONVILLE	WINDHAM	
3. STREET AND NUMBER (and/or location)		57/66-6	
397 ROUTE 12 (1344 RIVERSIDE DR.)

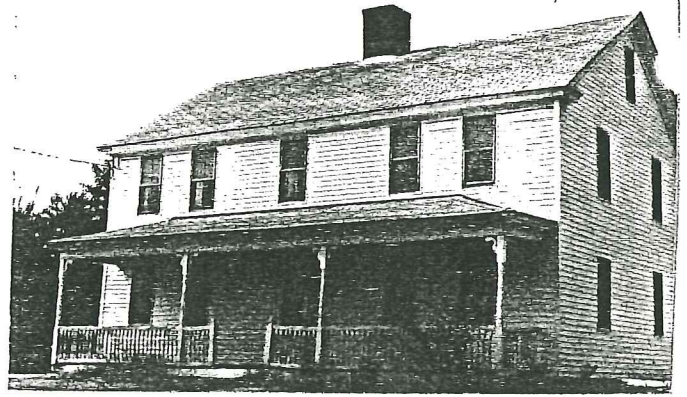
PHOTO	PHOTOGRAPHER Mark McDonough	DATE 1986
	VIEW SW	NEGATIVE ON FILE F12
COMPILED BY	NAME Mark McDonough	DATE 1986
	ORGANIZATION Town of Thompson, Connecticut	
	ADDRESS

11. NUMBER OF STORIES	APPROXIMATE DIMENSIONS		
2 1/2	35' x 26'		
12. CONDITION (Structural)			
<input type="checkbox"/> Excellent	<input checked="" type="checkbox"/> Good	<input type="checkbox"/> Fair	<input type="checkbox"/> Deteriorated
<input type="checkbox"/> Excellent	<input checked="" type="checkbox"/> Good	<input type="checkbox"/> Fair	<input type="checkbox"/> Deteriorated

13. INTEGRITY (Location)			
<input checked="" type="checkbox"/> On original site	<input type="checkbox"/> Moved	WHEN?	(Alterations) <input checked="" type="checkbox"/> Yes <input type="checkbox"/> No
IF YES, EXPLAIN: Later siding, late 19th century fabric

Five-bay facade, central entry, window bays paired and offset towards corners of house. Victorian wood door with single large elliptical light over panels. One-story full-width porch with turned posts and balusters, molded rail, small jigsaw brackets. Square posts with orb newels flank steps. Sash generally 2-over-2.

Second floor windows located relatively high under the eaves. Molded cornice shows partial return. Central brick chimney. Left elevation has side entry, cross-gabled one-and-one-half-story rear wing with porch on square tapered posts.
