HISTORIC RESOURCES INVENTORY
BUILDING AND STRUCTURES
 HIST-6 NEW 5/77

IDENTIFICATION	1. BUILDING NAME (Common) (Historic)		THE JOHN TOWN FARM		
	2. TOWN CITY	VILLAGE	COUNTY		
	THOMPSON	NORTH GROSVENORDALE	WINDHAM		
	3. STREET AND NUMBER (and/or location)		61+63/58-59		
	281 BUCKLEY HILL ROAD		(139 BUCKLEY Hill Rd.)

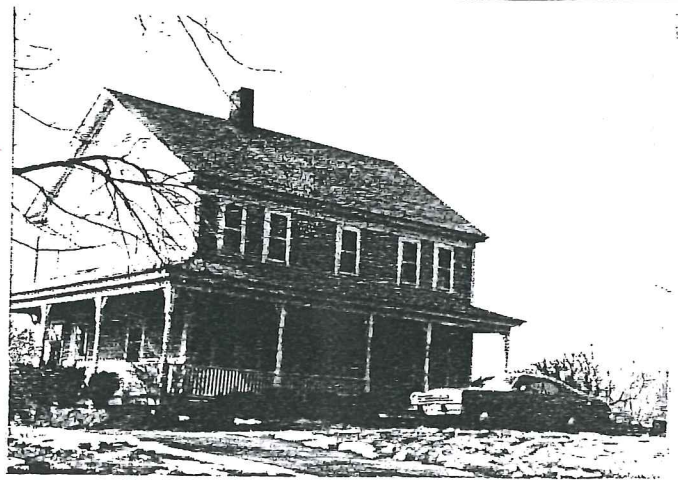
PHOTO	PHOTOGRAPHER Mark McDonough		DATE 1986
	VIEW W	NEGATIVE ON FILE E3	
COMPILED BY	NAME Mark McDonough		DATE 1986
	ORGANIZATION Town of Thompson, Connecticut		
	ADDRESS

Five-bay facade, central entry. Door has single large elliptical light with molded surround. Left and right bays paired and offset towards corners. Plain corner boards. Sashes generally 2-over-1. Full-width porch wraps across left elevation. Porch detail: square balusters, molded rail, turned posts, small jigsawn post brackets. Cornice details: molded architrave, plain frieze, denticular bed molding, molded cornice shows partial return. Single brick chimney is offset left.
