**HISTORIC RESOURCES INVENTORY
BUILDING AND STRUCTURES**

1. BUILDING NAME (Common) _____ (Historic) _____		
2. TOWN CITY THOMPSON	VILLAGE NORTH GROSVENORDALE	COUNTY WINDHAM
3. STREET AND NUMBER (and/or location) 82 BUCKLEY HILL ROAD (40 BUCKLEY HILL RD.)		61/59+62-11

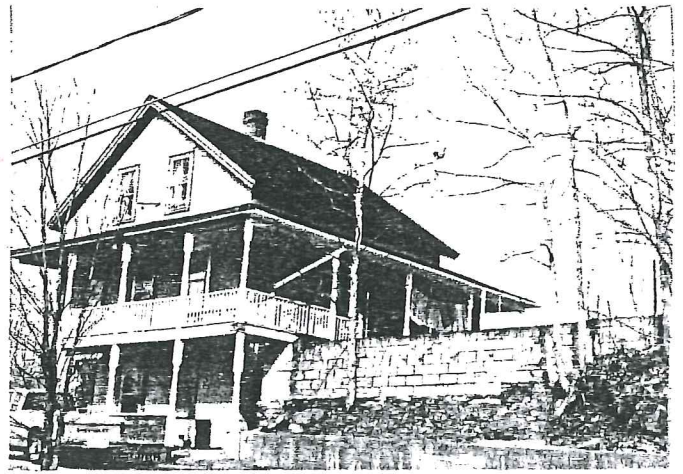
PHOTO	PHOTOGRAPHER Mark McDonough		DATE 1986
	VIEW NW	NEGATIVE ON FILE D19	
COMPILED BY	NAME Mark McDonough		DATE 1986
	ORGANIZATION Town of Thompson, Connecticut		
	ADDRESS

11. NUMBER OF STORIES 2 1/2	APPROXIMATE DIMENSIONS 24' x 26'	
12. CONDITION (Structural) _____ (Exterior) _____		
<input type="checkbox"/> Excellent <input type="checkbox"/> Good <input checked="" type="checkbox"/> Fair <input type="checkbox"/> Deteriorated	<input type="checkbox"/> Excellent <input type="checkbox"/> Good <input type="checkbox"/> Fair <input checked="" type="checkbox"/> Deteriorated

13. INTEGRITY (Location) <input checked="" type="checkbox"/> On original site	WHEN? _____	(Alterations) <input checked="" type="checkbox"/> Yes <input type="checkbox"/> No
IF YES, EXPLAIN extensive; siding, sash

Three-bay facade, central entry. Sash primarily 2-over-2, molded window surrounds. Two-story flat roofed porch has turned posts, square balusters, molded rail, plain frieze; most fabric is missing in first bay (all save roof).

Porch extends to right, wraps around right elevation to shelter side entry. Plain-board cornice, no return. Lower parallel rear extension.
