STATE OF CONNECTICUT
CONNECTICUT HISTORICAL COMMISSION
 59 SOUTH PROSPECT STREET, HARTFORD, CONNECTICUT 06106
 (203) 566-3005

1. BUILDING NAME (Common) _____ (Historic) _____	
2. TOWN CITY THOMPSON	VILLAGE NORTH GROSVENORDALE
3. STREET AND NUMBER (and/or location) 66 BUCKLEY HILL ROAD (28 BUCKLEY HILL Rd.)

7. STYLE OF BUILDING Greek Revival	
8. MATERIAL(S) (Indicate use or location when appropriate)	
<input type="checkbox"/> Clapboard	<input type="checkbox"/> Asbestos Siding
<input type="checkbox"/> Wood Shingle	<input type="checkbox"/> Asphalt Siding
<input type="checkbox"/> Board & Batten	<input type="checkbox"/> Stucco
<input checked="" type="checkbox"/> Aluminum Siding	<input type="checkbox"/> Concrete Type: _____
<input type="checkbox"/> Brick	<input checked="" type="checkbox"/> Other (Specify) Concrete block chimney
<input checked="" type="checkbox"/> Fieldstone	Steps & Foundation
<input type="checkbox"/> Cobblestone	
<input type="checkbox"/> Cut stone	Type: _____

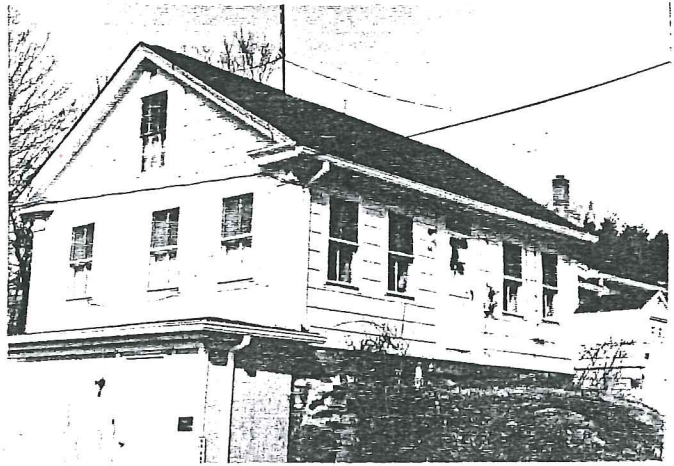
PHOTO	PHOTOGRAPHER Mark McDonough		DATE 1986
	VIEW NW	NEGATIVE ON FILE D14	
COMPILED BY	NAME Mark McDonough		DATE 1986
	ORGANIZATION Town of Thompson, Connecticut		
	ADDRESS

11. NUMBER OF STORIES 1 1/2	APPROXIMATE DIMENSIONS 22' x 28'
12. CONDITION (Structural) _____ (Exterior) _____	
<input type="checkbox"/> Excellent <input checked="" type="checkbox"/> Good <input type="checkbox"/> Fair <input type="checkbox"/> Deteriorated	<input type="checkbox"/> Excellent <input type="checkbox"/> Good <input checked="" type="checkbox"/> Fair <input type="checkbox"/> Deteriorated

Five-bay facade, central entry, sash generally 2-over-2. Plain entry pilasters, paneled wood door, rectangular glazed transom, wide plain corner pilasters. To right, lower parallel modern addition. Left has added flat roofed wing on raised basement level.
