HISTORIC RESOURCES INVENTORY
BUILDING AND STRUCTURES
 HIST-6 NEW 5/77

1. BUILDING NAME (Common)		(Historic)	
THOMPSON		VILLAGE GROSVENORDALE	COUNTY WINDHAM
3. STREET AND NUMBER (and/or location)		63/100-42	
435 REARDON ROAD (224 REARDON RO.)

7. STYLE OF BUILDING		DATE OF CONSTRUCTION	
Bungalow		c. 1918	
8. MATERIAL(S) (Indicate use or location when appropriate)			
<input checked="" type="checkbox"/> Clapboard <input type="checkbox"/> Asbestos Siding <input checked="" type="checkbox"/> Chimney Brick <input type="checkbox"/> Other (Specify)			
<input checked="" type="checkbox"/> Wood Shingle <input type="checkbox"/> Asphalt Siding <input type="checkbox"/> Fieldstone			
<input type="checkbox"/> Board & Batten <input type="checkbox"/> Stucco <input checked="" type="checkbox"/> Cobblestone Porch piers			
<input type="checkbox"/> Aluminum Siding <input type="checkbox"/> Concrete Type: <input type="checkbox"/> Cut stone Type:

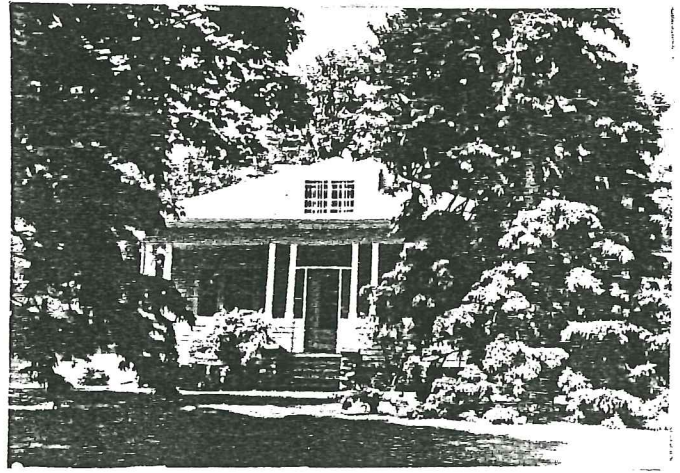
PHOTO	PHOTOGRAPHER Mark McDonough		DATE 1986
	VIEW W	NEGATIVE ON FILE M19	
COMPILED BY	NAME Mark McDonough		DATE 1986
	ORGANIZATION Town of Thompson, Connecticut		
	ADDRESS

11. NUMBER OF STORIES		APPROXIMATE DIMENSIONS	
1 1/2		30' x 24'	
12. CONDITION (Structural)			
(Exterior)			
<input type="checkbox"/> Excellent <input checked="" type="checkbox"/> Good <input type="checkbox"/> Fair <input type="checkbox"/> Deteriorated <input type="checkbox"/> Excellent <input checked="" type="checkbox"/> Good <input type="checkbox"/> Fair <input type="checkbox"/> Deteriorated

Three-bay facade, central entry. Small pane door, triple windows left and right (8-over-1 sash flanked by 4-over-1). Roofline extends for full width front porch. Paired slender tapered square posts with angular moldings at tops (after Tuscan).

Cobble porch piers, stair walls. Overhanging eaves. Large shed-roofed central roof dormer. Left: 8-over-1 sash, relatively plain. Right elevation: one story flat roofed c. 1940 addition.
