**HISTORIC RESOURCES INVENTORY  
BUILDING AND STRUCTURES**

IDENTIFICATION	1. BUILDING NAME (Common) _____ (Historic) _____	
	2. TOWN CITY THOMPSON	VILLAGE GROSVENORDALE
	3. STREET AND NUMBER (and/or location) 1604 ROUTE 12 (661 RIVERSIDE DR.)

4. OWNER(S) ROY, RICHARD B. & RUTH A., 169 GROVE STREET, PUTNAM, CT 06260	
	5. USE (Present) _____ (Historic) _____ Residence _____ ?	
	6. ACCESSIBILITY TO PUBLIC: <input checked="" type="checkbox"/> Yes <input type="checkbox"/> No	
DESCRIPTION	7. STYLE OF BUILDING Greek Revival

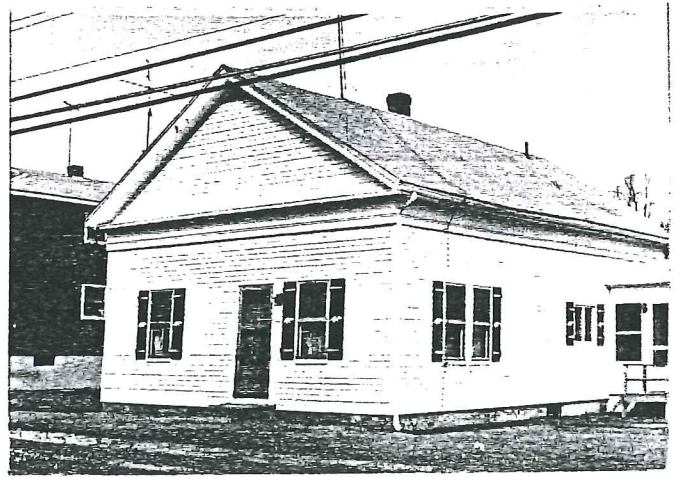
PHOTO	PHOTOGRAPHER Mark McDonough		DATE 1986
	VIEW NE	NEGATIVE ON FILE C29	
COMPILED BY	NAME Mark McDonough		DATE 1986
	ORGANIZATION Town of Thompson, Connecticut		
	ADDRESS

11. NUMBER OF STORIES   APPROXIMATE DIMENSIONS	
	1 1/2   26' x 41'	
	12. CONDITION (Structural) _____ (Exterior) _____	
<input type="checkbox"/> Excellent <input checked="" type="checkbox"/> Good <input type="checkbox"/> Fair <input type="checkbox"/> Deteriorated   <input type="checkbox"/> Excellent <input checked="" type="checkbox"/> Good <input type="checkbox"/> Fair <input type="checkbox"/> Deteriorated

13. INTEGRITY (Location) _____ WHEN? _____ (Alterations) _____ IF YES, EXPLAIN _____		
<input type="checkbox"/> On original site <input checked="" type="checkbox"/> Moved after 1887 <input checked="" type="checkbox"/> Yes <input type="checkbox"/> No   Siding, new entry, right rear porch

Three-bay facade, entry grouped with right window bay. Molded frieze; molded cornice shows full return. Sash a mix of 2-over-2 and 2-over-1. Most visible fabric recent.

The prominent frieze and pedimented peak mark this structure as a Greek Revival building constructed about 1850. The building's early history remains unclear.
