**HISTORIC RESOURCES INVENTORY**  
**BUILDING AND STRUCTURES**  
 HIST-6 NEW 5-77

IDENTIFICATION	1. BUILDING NAME (Common) <span style="float: right;">(Historic)</span>	
	MILL HOUSING	
	2. TOWN CITY	VILLAGE
	THOMPSON	GROSVENORDALE
	3. STREET AND NUMBER (and/or location)	
	1508 ROUTE 12 & THATCHER ROAD (715 RIVERSIDE DR.) 63/58-23

7. STYLE OF BUILDING	
	Mill Housing	
	DATE OF CONSTRUCTION	
	c. 1865	
	8. MATERIAL(S) (Indicate use or location when appropriate)	
	<input type="checkbox"/> Clapboard <input type="checkbox"/> Asbestos Siding <input checked="" type="checkbox"/> Chimneys <input type="checkbox"/> Other (Specify) <input checked="" type="checkbox"/> Wood Shingle <input type="checkbox"/> Asphalt Siding <input checked="" type="checkbox"/> Fieldstone Foundation <input type="checkbox"/> Board & Batten <input type="checkbox"/> Stucco <input type="checkbox"/> Cobblestone <input type="checkbox"/> Aluminum Siding <input type="checkbox"/> Concrete Type: <input type="checkbox"/> Cut stone Type:

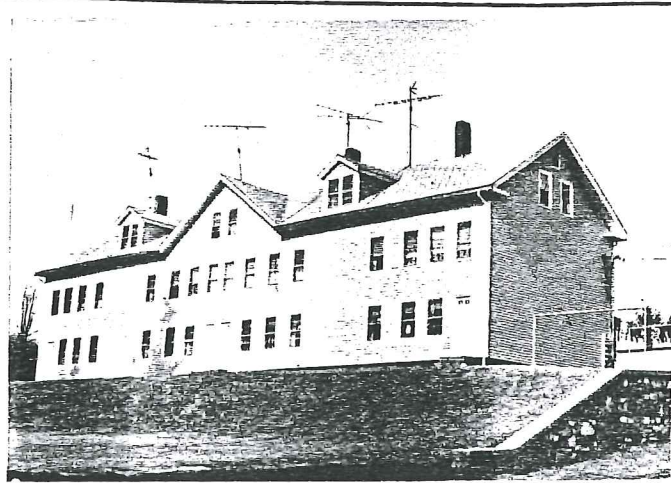
PHOTO	PHOTOGRAPHER Mark McDonough		DATE 1986
	VIEW NE & NE	NEGATIVE ON FILE D6 & D7	
COMPILED BY	NAME Mark McDonough		DATE 1986
	ORGANIZATION Town of Thompson, Connecticut		
	ADDRESS

11. NUMBER OF STORIES		
2 1/2		
APPROXIMATE DIMENSIONS		
100' x 30'		
12. CONDITION (Structural) <span style="float: right;">(Exterior)</span>		
<input type="checkbox"/> Excellent <input checked="" type="checkbox"/> Good <input type="checkbox"/> Fair <input type="checkbox"/> Deteriorated <input type="checkbox"/> Excellent <input type="checkbox"/> Good <input checked="" type="checkbox"/> Fair <input type="checkbox"/> Deteriorated

13. INTEGRITY (Location)		
<input checked="" type="checkbox"/> On original site <input type="checkbox"/> Moved <input type="checkbox"/> WHEN? <input type="checkbox"/> Alterations? <input checked="" type="checkbox"/> Yes <input type="checkbox"/> No IF YES, EXPLAIN Cornice brackets removed 1985

Sixteen-bay facade, grouped at sides and center. Entries in bays one, eight, nine, and sixteen. Large central gabled wall dormer, flanked by small gabled roof dormers. Sided cornice, partial return. Sides originally had six windows; most now blocked up.

Privies in rear.
