**HISTORIC RESOURCES INVENTORY**  
**BUILDING AND STRUCTURES**

IDENTIFICATION	1. BUILDING NAME (Common)		(Historic) MASONVILLE MILL HOUSING - TYPE B		
	2. TOWN CITY THOMPSON		VILLAGE GROSVENORDALE	COUNTY WINDHAM	
	3. STREET AND NUMBER (and/or location)		1553 ROUTE 12 (690 RIVERSIDE DR.) 63/94A-2

CONTINUATION SHEET #19 MASONVILLE MILL HOUSING - TYPE B  
 Item number: \_\_\_\_\_ Date: \_\_\_\_\_

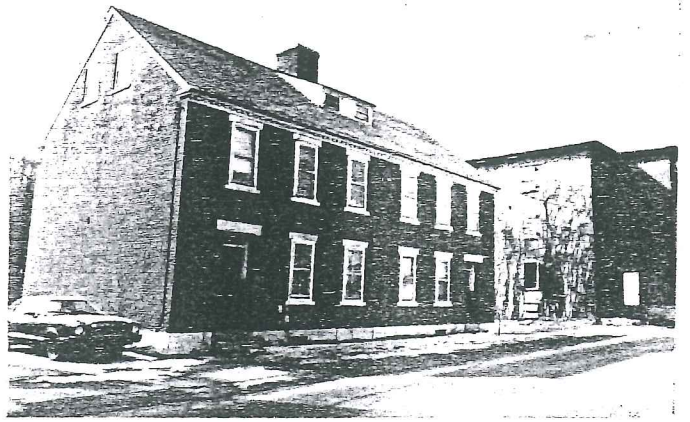
PHOTO	PHOTOGRAPHER Mark McDonough		DATE 1986
	VIEW NW	NEGATIVE ON FILE C34	
COMPILED BY	NAME Mark McDonough		DATE 1986
	ORGANIZATION Town of Thompson, Connecticut		
	ADDRESS

11. NUMBER OF STORIES		APPROXIMATE DIMENSIONS			
2 1/2		50' x 29'			
12. CONDITION (Structural)					
<input type="checkbox"/> Excellent <input checked="" type="checkbox"/> Good <input type="checkbox"/> Fair <input type="checkbox"/> Deteriorated <input type="checkbox"/> Excellent (Exterior) <input checked="" type="checkbox"/> Good <input type="checkbox"/> Fair <input type="checkbox"/> Deteriorated

Six-bay facade, left and right entries. Brick walls laid up in common bond with occasional header courses. Stone sills and lintels, second floor windows just under eaves. Brick dentil course at eaves; molded cornice shows partial return

Central shed-roofed roof dormer, central brick chimney. Sash is mixed, with some old 12-over-12; also 8-over-8, 1-over-1, 2-over-2, 6-over-6, 4-over-4 sash in dormers.
