**HISTORIC RESOURCES INVENTORY**  
**BUILDING AND STRUCTURES**

IDENTIFICATION	1. BUILDING NAME (Common)		(Historic)	
			ELLIOTT FARM	
	2. TOWN CITY	VILLAGE	COUNTY	
	THOMPSON	NO. GROSVENORDALE	WINDHAM	
	3. STREET AND NUMBER (and/or location)		65/101-6	
	592 REARDON ROAD (307 REARDON RO.)

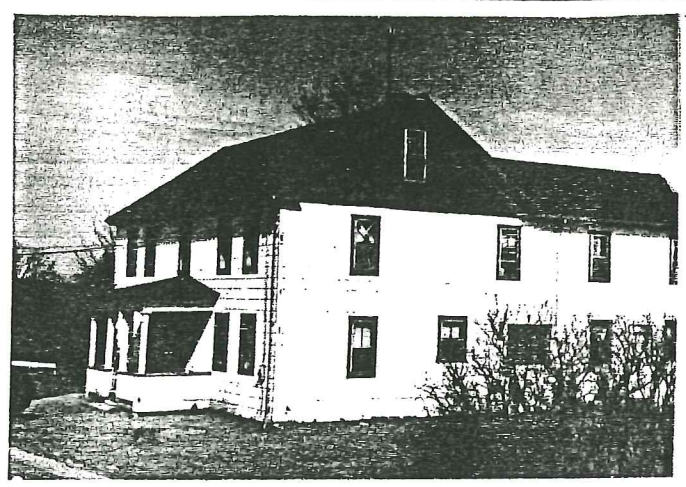
PHOTO	PHOTOGRAPHER Mark McDonough	DATE 1986
	VIEW NE	NEGATIVE ON FILE K11
COMPILED BY	NAME Mark McDonough	DATE 1986
	ORGANIZATION Town of Thompson, Connecticut	
	ADDRESS

Five-bay facade, central entry. Sash generally 2-over-2. Window bays paired and offset towards the corners of the house. Entry is altered: later paneled door flanked by deep panels (perhaps altered sidelights), then fluted pilasters.

Extremely wide frieze above. Single bay entry porch has sided railing, square chamfered posts. Second floor windows are located relatively high under the eaves. Molded cornice shows partial return. Single chimney is offset left. Large two story cross-gabled rear addition. Interiors are remodelled since 1960.
