**HISTORIC RESOURCES INVENTORY**  
**BUILDING AND STRUCTURES**  
 HIST-6 NEW 5/77

1. BUILDING NAME (Common)		(Historic)	
THOMPSON		MECHANICSVILLE MILL HOUSING	
2. TOWN CITY	VILLAGE	COUNTY	
THOMPSON	MECHANICSVILLE	WINDHAM	
3. STREET AND NUMBER (and/or location)		67/96-11A	
44 OLD ROUTE 12 (24 OLD RT. 12)			
4. OWNER(S)			
BRIER, ALFRED H. JR. & JUNE M., 62 ARTHUR ST., PUTNAM, CT 06260			
5. USE (Present)			
Residence		Residence	
(Historic)			
6. ACCESSIBILITY TO PUBLIC:			
EXTERIOR VISIBLE FROM PUBLIC ROAD		INTERIOR ACCESSIBLE	
<input checked="" type="checkbox"/> Yes <input type="checkbox"/> No		<input type="checkbox"/> Yes <input checked="" type="checkbox"/> No	
IF YES, EXPLAIN

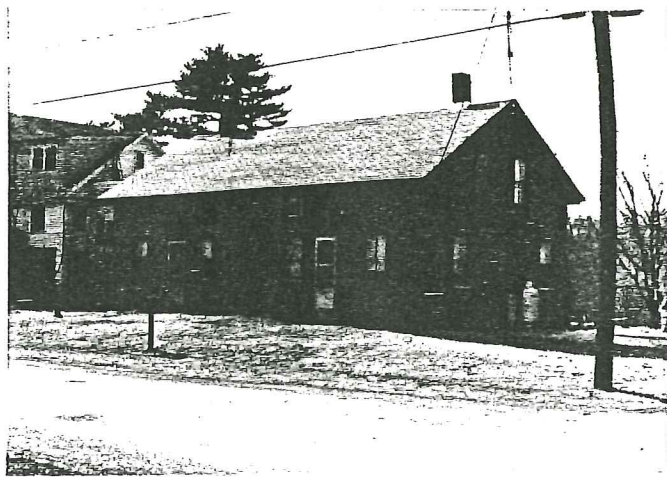
PHOTO	PHOTOGRAPHER Mark McDonough		DATE 1986
	VIEW SW	NEGATIVE ON FILE F24	
COMPILED BY	NAME Mark McDonough		DATE 1986
	ORGANIZATION Town of Thompson, Connecticut		
	ADDRESS

11. NUMBER OF STORIES		APPROXIMATE DIMENSIONS	
1 1/2		44' X 26'	
12. CONDITION (Structural)			
<input type="checkbox"/> Excellent	<input checked="" type="checkbox"/> Good	<input type="checkbox"/> Fair	<input type="checkbox"/> Deteriorated
(Exterior)			
<input type="checkbox"/> Excellent	<input checked="" type="checkbox"/> Good	<input type="checkbox"/> Fair	<input type="checkbox"/> Deteriorated

13. INTEGRITY (Location)			
<input checked="" type="checkbox"/> On original site	<input type="checkbox"/> Moved	WHEN?	(Alterations)
			<input checked="" type="checkbox"/> Yes <input type="checkbox"/> No
IF YES, EXPLAIN			
transoms boarded up

Six-bay facade with entries in second and fifth bays. Entries have boarded-up transom, simple molded cap. Sash generally 2-over-2, small frieze-band windows with 3-over-3 in bays three and four. Plain corner boards and frieze, molded cornice. Side elevation plain.
