HISTORIC RESOURCES INVENTORY
BUILDING AND STRUCTURES

IDENTIFICATION	1. BUILDING NAME (Common) (Historic)		THEOPHILUS CHANDLER HOUSE	
	2. TOWN CITY		VILLAGE	COUNTY
	THOMPSON			WINDHAM
	3. STREET AND NUMBER (and/or location)			
	150 NORMAN HILL ROAD		(80 NORMAN HILL RD.)	
	7 + 21/105-65

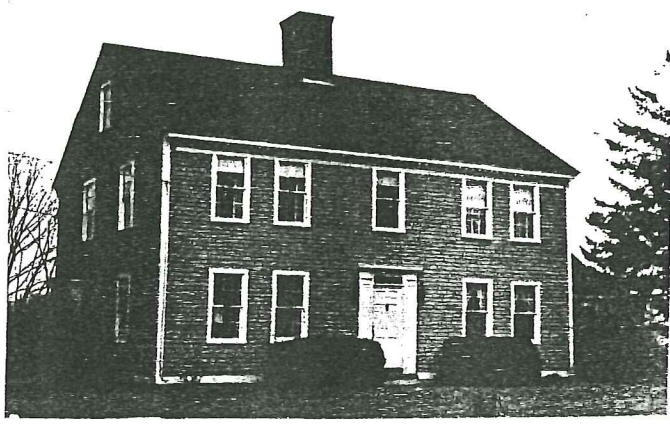
PHOTO	PHOTOGRAPHER Mark McDonough		DATE 1986
	VIEW NE	NEGATIVE ON FILE K32	
COMPILED BY	NAME Mark McDonough		DATE 1986
	ORGANIZATION Town of Thompson, Connecticut		
	ADDRESS

Five-bay facade, central entry. Window bays paired and offset toward corners of house. Entry extensively repaired; paneled wood door, fluted pilasters, rectangular glazed transom with denticular molded cap. Windows have new 6-over-6 sash; frames are old pegged oak.

Second floor windows are fitted into cornice bed molding. Above, delicate dentils, then molded cornice with modillions cornice shows partial return. Large central brick chimney.

Left elevation has modern bay window to rear. Right has old lower parallel wing. Interiors have considerable original fabric, including denticular crown moldings, six-paneled doors. Corner posts and beams are boxed, with beaded corners (no exposed summer beams).
