HISTORIC RESOURCES INVENTORY
BUILDING AND STRUCTURES
 HIST-6 NEW 5/77

IDENTIFICATION	1. BUILDING NAME (Common) (Historic) MARCUS TOWNE FARM	
	2. TOWN CITY THOMPSON	VILLAGE NORTH GROSVENORDALE
	3. STREET AND NUMBER (and/or location) 734 PASAY ROAD 81/43-25

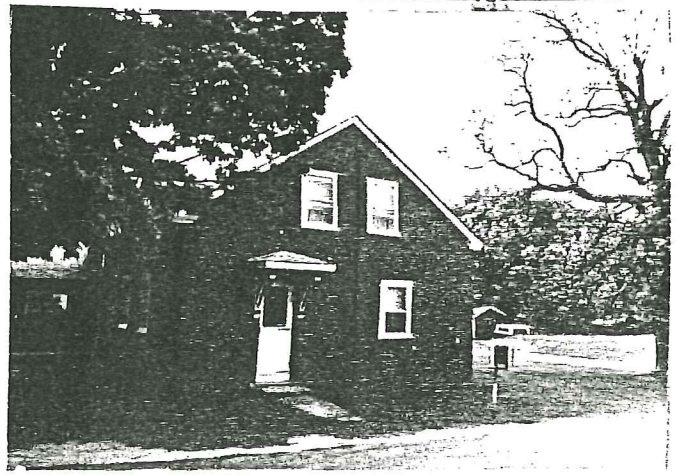
PHOTO	PHOTOGRAPHER Mark McDonough		DATE 1986
	VIEW SE	NEGATIVE ON FILE M7	
COMPILED BY	NAME Mark McDonough		DATE 1986
	ORGANIZATION Town of Thompson, Connecticut		
	ADDRESS

11. NUMBER OF STORIES APPROXIMATE DIMENSIONS		
1 1/2 27' x 45'		
12. CONDITION (Structural) (Exterior)		
<input type="checkbox"/> Excellent <input checked="" type="checkbox"/> Good <input type="checkbox"/> Fair <input type="checkbox"/> Deteriorated <input type="checkbox"/> Excellent <input checked="" type="checkbox"/> Good <input type="checkbox"/> Fair <input type="checkbox"/> Deteriorated

Two-bay facade with left entry. Wood door has twin round arched lights. Entry hood on large jigsawn consoles with carved floral designs and turned pendants. Exterior walls stucco over fieldstone, banded brick edging around most window openings. Sash generally 2-over-2. Molded cornice with partial return.

Right elevation has entry in fifth bay (six deep). Left elevation has heavily altered or added cross-gabled rear wing, wood frame with 2-over-2.
