**HISTORIC RESOURCES INVENTORY
BUILDING AND STRUCTURES**

IDENTIFICATION	1. BUILDING NAME (Common) _____ (Historic) _____	
	2. TOWN CITY THOMPSON	VILLAGE GROSVENORDALE
	3. STREET AND NUMBER (and/or location) 52 KLONDIKE ST. & LAPORTE ST. (25 KLONDIKE ST.) 83/56-35

6. ACCESSIBILITY TO PUBLIC: <input checked="" type="checkbox"/> Yes <input type="checkbox"/> No EXTERIOR VISIBLE FROM PUBLIC ROAD <input type="checkbox"/> Yes <input checked="" type="checkbox"/> No INTERIOR ACCESSIBLE <input type="checkbox"/> Yes <input checked="" type="checkbox"/> No IF YES, EXPLAIN _____	
DESCRIPTION	7. STYLE OF BUILDING Victorian Vernacular	
	DATE OF CONSTRUCTION c. 1880

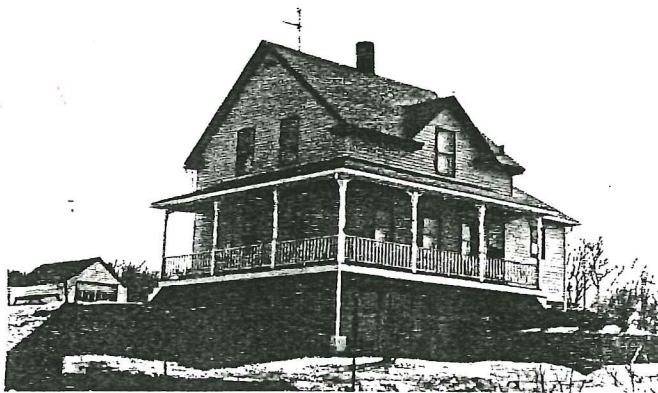
PHOTO	PHOTOGRAPHER Mark McDonough		DATE 1986
	VIEW SW	NEGATIVE ON FILE L8	
COMPILED BY	NAME Mark McDonough		DATE 1986
	ORGANIZATION Town of Thompson, Connecticut		
	ADDRESS

11. NUMBER OF STORIES 2 1/2		
APPROXIMATE DIMENSIONS 26' x 26'		
12. CONDITION (Structural) _____ (Exterior) _____ <input type="checkbox"/> Excellent <input checked="" type="checkbox"/> Good <input type="checkbox"/> Fair <input type="checkbox"/> Deteriorated <input type="checkbox"/> Excellent <input checked="" type="checkbox"/> Good <input type="checkbox"/> Fair <input type="checkbox"/> Deteriorated

Three-bay facade, central entry is offset to left. Raised basement story has additional entry on right elevation. One story full width porch wraps around right corner, framed in at right rear. Porch has turned posts, jigsawn post brackets, square balusters, molded rail. Plain corner boards and frieze; molded cornice shows partial return.

Right elevation: side entry under porch, gabled wall dormer. Left has side entry with modern metal hood, similar wall dormer.
