**HISTORIC RESOURCES INVENTORY**  
**BUILDING AND STRUCTURES**  
 HIST-6 NEW 5/77

1. BUILDING NAME (Common) _____ (Historic) _____		GROSVENORDALE MILL HOUSING	
2. TOWN CITY THOMPSON		VILLAGE GROSVENORDALE	COUNTY WINDHAM
3. STREET AND NUMBER (and/or location) 40 KLONDIKE STREET (34 KLONDIKE ST.)		83/57-21

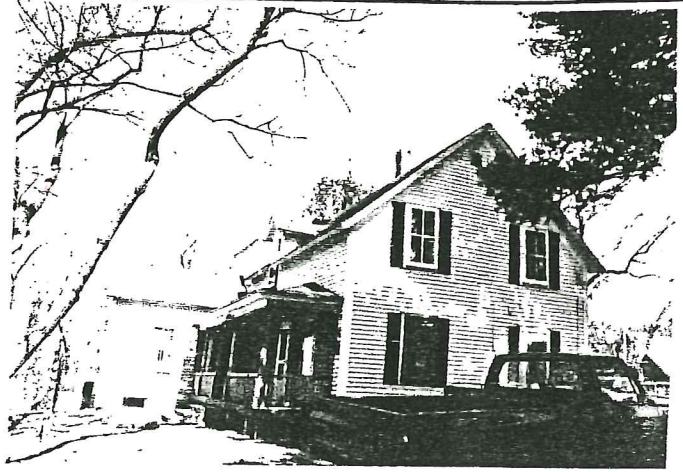
PHOTO	PHOTOGRAPHER Mark McDonough		DATE 1986
	VIEW NE	NEGATIVE ON FILE L13	
COMPILED BY	NAME Mark McDonough		DATE 1986
	ORGANIZATION Town of Thompson, Connecticut		
	ADDRESS

11. NUMBER OF STORIES 1 1/2		APPROXIMATE DIMENSIONS 24' x 28'	
12. CONDITION (Structural) _____ (Exterior) _____			
<input type="checkbox"/> Excellent	<input checked="" type="checkbox"/> Good	<input type="checkbox"/> Fair	<input type="checkbox"/> Deteriorated
<input type="checkbox"/> Excellent	<input checked="" type="checkbox"/> Good	<input type="checkbox"/> Fair	<input type="checkbox"/> Deteriorated

13. INTEGRITY (Location)		WHEN ?	(Alterations)
<input checked="" type="checkbox"/> On original site	<input type="checkbox"/> Moved		<input checked="" type="checkbox"/> Yes <input type="checkbox"/> No
			IF YES, EXPLAIN c. 1890 porch

Three bays of original facade are exposed; cross-gabled wing projects from left front corner. One story front porch on turned posts has square balusters, molded rail. Central entry; additional entry in right wall of wing. Sash generally 2-over-2.
