HISTORIC RESOURCES INVENTORY
BUILDING AND STRUCTURES
 HIST-6 NEW 5/77

IDENTIFICATION	1. BUILDING NAME (Common) (Historic)		THE CUMMINGS HOUSE	
	2. TOWN CITY	VILLAGE	COUNTY	
	THOMPSON	THOMPSON	WINDHAM	
	3. STREET AND NUMBER (and/or location)		103/40-7	
	847 SUNSET HILL ROAD (72 SUNSET HILL RD.)

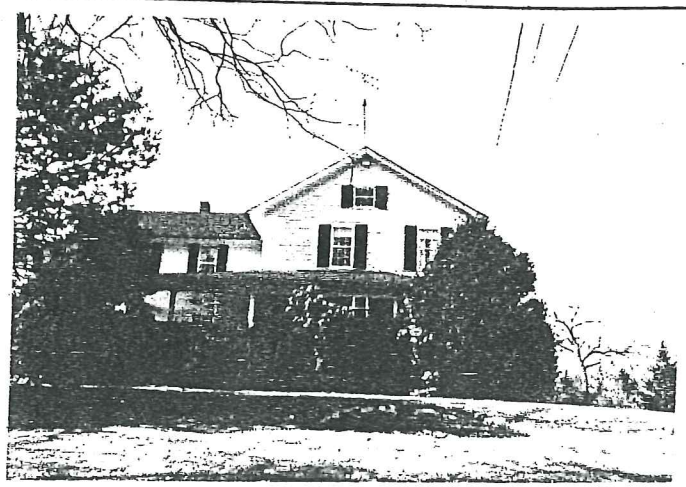
11. NUMBER OF STORIES		APPROXIMATE DIMENSIONS		
2 1/2		22' x 30' (main); 24' x 18 (ell)		
12. CONDITION (Structural) (Exterior)				
<input type="checkbox"/> Excellent <input checked="" type="checkbox"/> Good <input type="checkbox"/> Fair <input type="checkbox"/> Deteriorated <input type="checkbox"/> Excellent <input checked="" type="checkbox"/> Good <input type="checkbox"/> Fair <input type="checkbox"/> Deteriorated

Facade has two bays over three, left entry. Paneled wood door, rectangular sidelights over panels, all in plain board surround with flat molded cap above. One-story full width porch extends across old lower left ell.

Porch detail: Tuscan columns, turned balusters, molded rail, plain frieze. Sash generally 6-over-6. Windows have flat molded caps. Wide plain frieze and corner boards; molded cornice shows no return.
