HISTORIC RESOURCES INVENTORY
BUILDING AND STRUCTURES
 HIST-6 NEW 5/77

1. BUILDING NAME (Common)		(Historic) JOSEPH PERRY BIXBY HOUSE	
2. TOWN CITY THOMPSON	VILLAGE THOMPSON	COUNTY WINDHAM	
3. STREET AND NUMBER (and/or location) 885 SUNSET HILL ROAD		(54 SUNSET HILL RD.) 103/40-9	
4. OWNER(S) MCNEIL, DAVID T. & SANDRA F., RR 2, THOMPSON, CT 06277		<input type="checkbox"/> Public <input checked="" type="checkbox"/> Private	
5. USE (Present) Residence		(Historic) Residence	
6. ACCESSIBILITY TO PUBLIC:	EXTERIOR VISIBLE FROM PUBLIC ROAD <input checked="" type="checkbox"/> Yes <input type="checkbox"/> No	INTERIOR ACCESSIBLE <input type="checkbox"/> Yes <input checked="" type="checkbox"/> No	IF YES, EXPLAIN

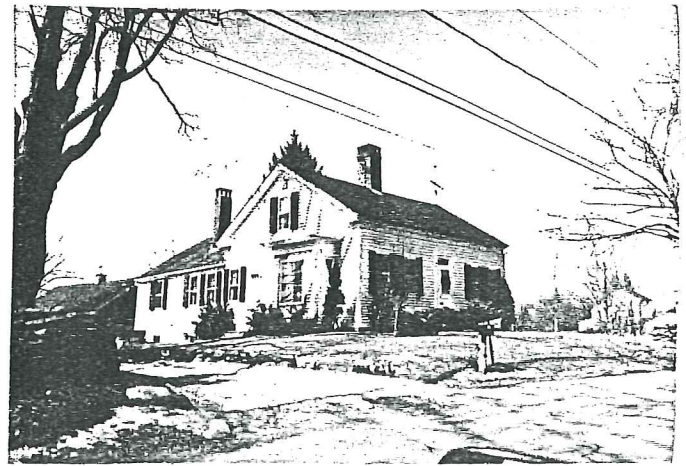
PHOTO	PHOTOGRAPHER Mark McDonough		DATE 1986
	VIEW W	NEGATIVE ON FILE I34	
COMPILED BY	NAME Mark McDonough		DATE 1986
	ORGANIZATION Town of Thompson, Connecticut		
	ADDRESS

11. NUMBER OF STORIES 1 1/2		APPROXIMATE DIMENSIONS 32' x 24' (main part)	
12. CONDITION (Structural)			
<input type="checkbox"/> Excellent	<input checked="" type="checkbox"/> Good	<input type="checkbox"/> Fair	<input type="checkbox"/> Deteriorated
(Exterior)			
<input type="checkbox"/> Excellent	<input checked="" type="checkbox"/> Good	<input type="checkbox"/> Fair	<input type="checkbox"/> Deteriorated

13. INTEGRITY (Location)			
<input checked="" type="checkbox"/> On original site	<input type="checkbox"/> Moved	WHEN?	(Alterations) <input checked="" type="checkbox"/> Yes <input type="checkbox"/> No IF YES, EXPLAIN Modern storm sash, rebuilt chimney

DESCRIPTION (Continued)	17 OTHER NOTABLE FEATURES OF BUILDING OR SITE (interior and/or exterior)	
	<p>Five-bay facade, central entry. Paneled wood door, entry surround of plain boards. Rectangular glazed transome. Sash generally 2-over-2. Molded architrave, narrow plain frieze, bed molding.</p> <p>Molded cornice shows partial return. Central brick chimney. Left elevation has one-story rectangular bay window with narrow 1-over-1 sash, molded window caps. Right elevation plain; walls out of plumb. Attached sheds and barn to rear.</p>	
SIGNIFICANCE	18 ARCHITECT	BUILDER
	<p>19 HISTORICAL OR ARCHITECTURAL IMPORTANCE</p> <p>Joseph Perry Bixby was an early and longtime occupant of this house which dates to the later years of the 18th century. Little could be discovered about Joseph Perry Bixby, in part due to confusion in town records and atlases between Joseph Perry and his relative Joseph Prince Bixby. Joseph Perry Bixby lived in this house from before 1855 until he sold it in 1885. During his ownership, the house was extensively remodelled. The central chimney, ridge-parallel-to-street form, and timber frame (indicated by out-of-plumb walls) support an 18th century origin for the house. The bay window, 2-over-2 sash, and attached agricultural buildings are all 19th century features.</p> <p>Architecturally, the Bixby House is significant as an example of an 18th century vernacular dwelling with 19th century modifications.</p> <p>Historically, it is significant as part of a large assemblage of older houses surrounding the nearby Thompson Green (located just to the southeast).</p>
