**HISTORIC RESOURCES INVENTORY
BUILDING AND STRUCTURES**
HIST-6 NEW 5/77

IDENTIFICATION	1. BUILDING NAME (Common) (Historic)		MUNYAN FARM		
	2. TOWN CITY	VILLAGE	COUNTY		
	THOMPSON	THOMPSON	WINDHAM		
	3. STREET AND NUMBER (and/or location)			103/40-1	
	1707 ROUTE 193 (444 THOMASON RD.)

7. STYLE OF BUILDING			DATE OF CONSTRUCTION		
Vernacular/Greek Revival			c. 1800		
8. MATERIAL(S) (Indicate use or location when appropriate)					
<input checked="" type="checkbox"/> Clapboard	<input type="checkbox"/> Asbestos Siding	<input checked="" type="checkbox"/> Chimneys	<input type="checkbox"/> Other (Specify)		
<input type="checkbox"/> Wood Shingle	<input type="checkbox"/> Asphalt Siding	<input checked="" type="checkbox"/> Brick	<input type="checkbox"/> Fieldstone Foundation		
<input type="checkbox"/> Board & Batten	<input type="checkbox"/> Stucco	<input type="checkbox"/> Cobblestone			
<input type="checkbox"/> Aluminum Siding	<input type="checkbox"/> Concrete Type:	<input type="checkbox"/> Cut stone Type:

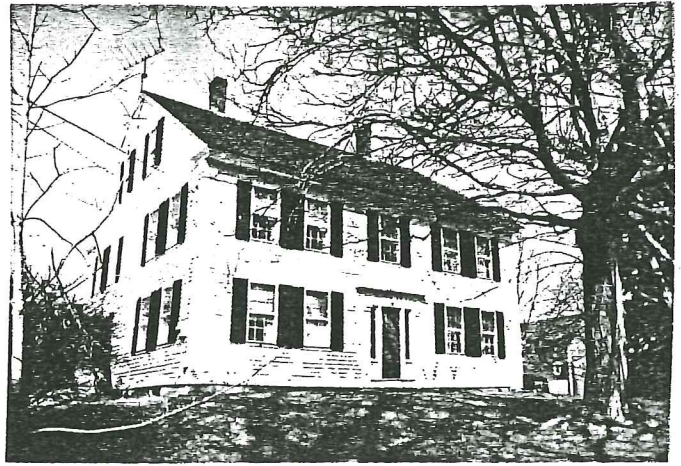
PHOTO	PHOTOGRAPHER Mark McDonough		DATE 1986
	VIEW NW	NEGATIVE ON FILE I33	
COMPILED BY	NAME Mark McDonough		DATE 1986
	ORGANIZATION Town of Thompson, Connecticut		
	ADDRESS		
SUBSEQUENT FIELD EVALUATION:

Five-bay facade, central entry, sash generally old 6-over-6. Entry has old paneled wood door, rectangular sidelights. Wide paneled entry pilasters with molded capitals, very wide plain frieze with flat molded cap. Window bays paired and offset towards corners of house. Plain corner pilasters with molded capitals. Plain frieze. Molded cornice shows partial return.

Twin brick chimneys. Right elevation has side entry with paneled pilasters, lintels, and corner blocks, some 12-over-12 sash. Old lower wings to rear. Side elevation windows paired.
