HISTORIC RESOURCES INVENTORY
BUILDING AND STRUCTURES
HIST-6 NEW 5/77

IDENTIFICATION	1. BUILDING NAME (Common) (Historic) GEORGE CROSBY HOUSE	
	2. TOWN CITY THOMPSON	VILLAGE THOMPSON
	3. STREET AND NUMBER (and/or location) 1830 ROUTE 193 375 Thompson Rd.

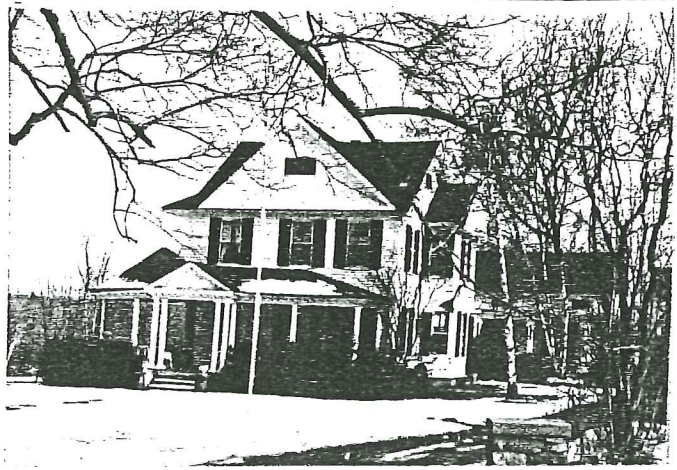
PHOTO	PHOTOGRAPHER Mark McDonough	DATE 1986
	VIEW NE	NEGATIVE ON FILE E18
COMPILED BY	NAME Mark McDonough	DATE 1986
	ORGANIZATION Town of Thompson, Connecticut	
	ADDRESS

11. NUMBER OF STORIES APPROXIMATE DIMENSIONS	
	2 1/2 25' x 30' (main part)	
12. CONDITION (structural) (Exterior)		
<input type="checkbox"/> Excellent <input checked="" type="checkbox"/> Good <input type="checkbox"/> Fair <input type="checkbox"/> Deteriorated <input type="checkbox"/> Excellent <input checked="" type="checkbox"/> Good <input type="checkbox"/> Fair <input type="checkbox"/> Deteriorated

Three-bay facade, left entry. Sash generally 2-over-2, oversized on first floor of facade. One story full width porch on Tuscan columns has pedimented peak with carved sunburst centered on entry, extends at left to form rounded pavillion with conical roof with small wood finial.

Porch has turned balusters, molded rail, molded architrave, plain frieze, molded cornice with small jigsaw brackets. House has plain corner boards and frieze, overhanging eaves, molded cornice. Facade has pedimented peak with bevelled shingles. Attic light has 18 small panes. Left elevation has border pane staircase window. Right elevation has two-and-one-half-story bay window, bevelled, squared at second floor on large consoles with sunburst carvings.

Pedimented peak has applied boards in a chevron pattern. Large right-rear cross-gabled one-and-one-half-story wing has one story porch on lattice posts.
