HISTORIC RESOURCES INVENTORY

BUILDING AND STRUCTURES

WINTHROP N. OSGOOD HOUSE

1908 ROUTE 193

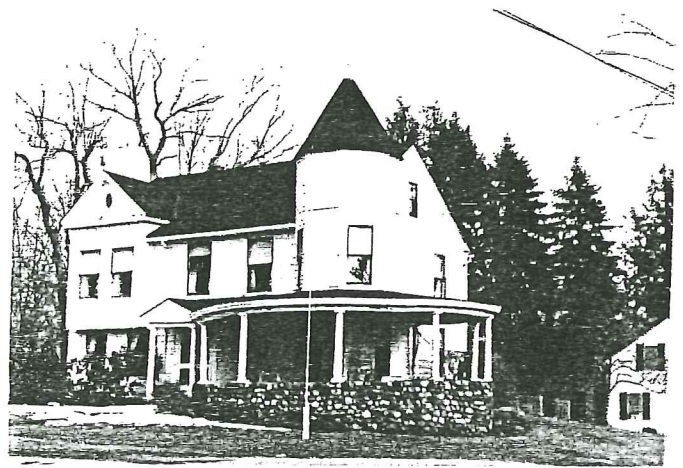
PHOTO	PHOTOGRAPHER Mark McDonough		DATE 1986
	VIEW NE	NEGATIVE ON FILE E24	
COMPILED BY	NAME Mark McDonough		DATE 1986
	ORGANIZATION Town of Thompson, Connecticut		
	ADDRESS

DESCRIPTION (Continued)	17 OTHER NOTABLE FEATURES OF BUILDING OR SITE (interior and/or exterior)
	<p>Basic form is rectangular, oriented ridge-parallel-to-street. Five-bay, central entry, double wood doors. Sash generally old 1-over-1. On left, two-bay cantilevered bay window has pedimented peak, molded cornice, elliptical attic window, wood shingles in peak. Gabled entry shelter on Tuscan-columns has molded cornice, pedimented peak with clapboard sunburst. To right, Tuscan-columned porch with cobble railing forms large round pavillion topped Tuscan-columned porch with cobble railing forms, large round pavillion topped by octagonal tower with wood finial. Side elevation relatively plain; cross-gabled rear wing.</p>
