HISTORIC RESOURCES INVENTORY
BUILDING AND STRUCTURES
 HIST-6 NEW 5/77

1. BUILDING NAME (Common) (Historic)		ASA ROSS HOUSE	
2. TOWN CITY	VILLAGE	COUNTY	
THOMPSON	THOMPSON HILL	WINDHAM	
3. STREET AND NUMBER (and/or location)			
1915 ROUTE 193		(330 THOMPSON RD.) 105/38-9

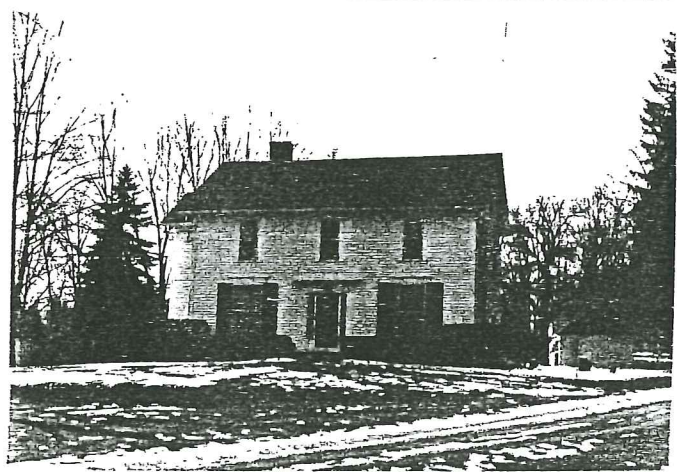
PHOTO	PHOTOGRAPHER Mark McDonough		DATE 1986
	VIEW SW	NEGATIVE ON FILE E26	
COMPILED BY	NAME Mark McDonough		DATE 1986
	ORGANIZATION Town of Thompson, Connecticut		
	ADDRESS

11. NUMBER OF STORIES		APPROXIMATE DIMENSIONS	
2 1/2		38' x 28'	
12. CONDITION (Structural) (Exterior)			
<input type="checkbox"/> Excellent	<input checked="" type="checkbox"/> Good	<input type="checkbox"/> Fair	<input type="checkbox"/> Deteriorated
<input type="checkbox"/> Excellent	<input checked="" type="checkbox"/> Good	<input type="checkbox"/> Fair	<input type="checkbox"/> Deteriorated

Three-bay facade, central entry. Very large first floor windows with simple molded caps; sash generally 2-over-2. Wide paneled door with twin rectangular panes. Rectangular sidelights, wide plain pilasters and lintel, simple molded cap. Plain frieze and corner boards; molded cornice shows partial return.

Single brick chimney offset left. Shallow left parallel wing. Large cross-gabled rear wing.
