STATE OF CONNECTICUT
CONNECTICUT HISTORICAL COMMISSION
59 SOUTH PROSPECT STREET, HARTFORD, CONNECTICUT 06106
(203) 566-3005

1. BUILDING NAME (Common)		(Historic)	
THOMPSON		TALCOTT CROSBY HOUSE (2)	
2. TOWN CITY	VILLAGE	COUNTY	
THOMPSON	THOMPSON	WINDHAM	
3. STREET AND NUMBER (and/or location)			
1855 ROUTE 193 (362 THOMPSON Rd.)		105/40-15	
4. OWNER(S)			
O'NEILL, ANN M. & JOSEPH B., BOX 62, THOMPSON, CT 06277			
5. USE (Present)			
Residence		(Historic) Residence	
6. ACCESSIBILITY TO PUBLIC:			
EXTERIOR VISIBLE FROM PUBLIC ROAD		INTERIOR ACCESSIBLE	
<input checked="" type="checkbox"/> Yes <input type="checkbox"/> No		<input type="checkbox"/> Yes <input checked="" type="checkbox"/> No

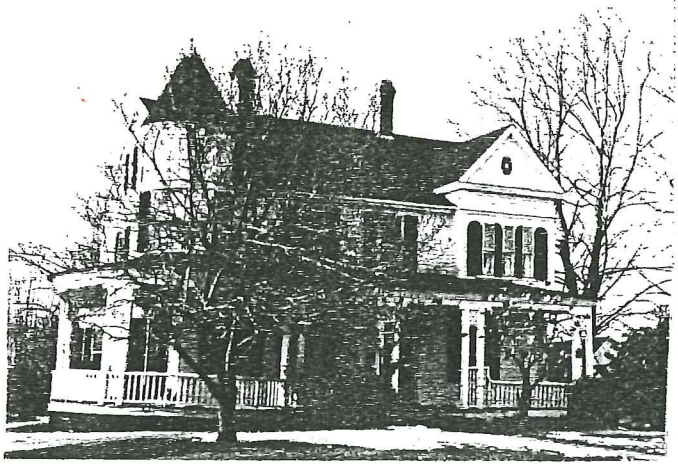
PHOTO	PHOTOGRAPHER Mark McDonough		DATE 1986
	VIEW NW	NEGATIVE ON FILE E22	
COMPILED BY	NAME Mark McDonough		DATE 1986
	ORGANIZATION Town of Thompson, Connecticut		
	ADDRESS

Four-bay facade, entry in third bay. Projecting right front gable, left front round tower. Tall double wood doors with large lights over panels. Paneled entry pilasters. Sash generally 2-over-2. One story full width porch extends to form rounded pavillion at left front.

Porch has paired square posts with infill panels with floral cut-outs. Post have plain capitals with turned circular bosses. Balusters generally square, turned and spindled to either side of entry steps. Molded rail.

Tower at left has paneled wall surface, molded cornice, conical roof with wood finial. Second floor has staggered-butt shingles. Right front gable has pedimented peak, paneled wall surface just below cornice, elliptical attic window with radical glazing, keyblock surround.
