HISTORIC RESOURCES INVENTORY
BUILDING AND STRUCTURES
 HIST-6 NEW 5:77

IDENTIFICATION	1. BUILDING NAME (Common) (Historic)		JOHN NICHOLS & THEODORE DWIGHT HOUSE		
	2. TOWN CITY	VILLAGE	COUNTY		
	THOMPSON	THOMPSON	WINDHAM		
	3. STREET AND NUMBER (and/or location)			105/40-16	
	16 ROUTE 200 & ROUTE 193 (376 THOMPSON Hill Rd.)

CONTINUATION SHEET JOHN NICHOLS & THEODORE DWIGHT HOUSE
Item number: _____ Date: _____

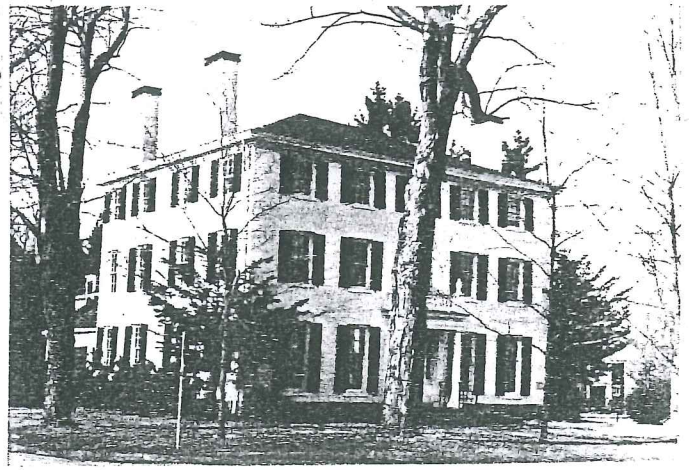
PHOTO	PHOTOGRAPHER Mark McDonough		DATE 1986
	VIEW NW	NEGATIVE ON FILE E23	
COMPILED BY	NAME Mark McDonough		DATE 1986
	ORGANIZATION Town of Thompson, Connecticut		
	ADDRESS

Five-bay facade, central Colonial Revival entry; flat-roofed Tuscan-columned portico with balustrade, square paneled newel posts with urns. Entry has sidelights with leaded star-and-circle glazing; radial-glazed rectangular transom has cast-lead eagle and floral decorations. Sash recent reproduction: 6-over-9 on first floor, 6-over-6 on second, splayed stone lintels and stone sills.

Cornice: bead molding, dentils, molded cornice. Third floor windows located high under eaves. Side elevations are similar with somewhat simplified window detailing. Rear frame wing. Interiors generally reflect 1930's Colonial Revival alterations.
