HISTORIC RESOURCES INVENTORY
BUILDING AND STRUCTURES
 HIST-6 NEW 5/77

1. BUILDING NAME (Common)		(Historic)	
THOMPSON		ERASTUS KNIGHT HOUSE (2)	
2. TOWN CITY	VILLAGE	COUNTY	
THOMPSON	THOMPSON	WINDHAM	
3. STREET AND NUMBER (and/or location)		105/40-18	
50 ROUTE 200 (358 THOMPSON Hill Rd.)			
4. OWNER(S)		<input type="checkbox"/> Public <input checked="" type="checkbox"/> Private	
SWANSON, ROLF & VIRGINIA, BOX 147, THOMPSON, CT 06277			
5. USE (Present)		(Historic)	
Residence		Residence	
6. ACCESSIBILITY TO PUBLIC:	EXTERIOR VISIBLE FROM PUBLIC ROAD	INTERIOR ACCESSIBLE	IF YES, EXPLAIN
<input checked="" type="checkbox"/> Yes <input type="checkbox"/> No	<input type="checkbox"/> Yes <input checked="" type="checkbox"/> No

ERASTUS KNIGHT HOUSE (2) ✓

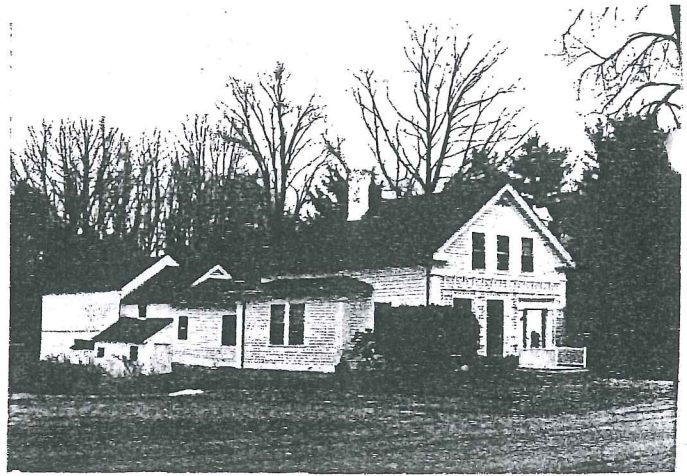
PHOTO	PHOTOGRAPHER Mark McDonough		DATE 1986
	VIEW NE & N	NEGATIVE ON FILE I17 & G23	
COMPILED BY	NAME Mark McDonough		DATE 1986
	ORGANIZATION Town of Thompson, Connecticut		
	ADDRESS		
20 SUBSEQUENT FIELD EVALUATION

DESCRIPTION (Continued)	17 OTHER NOTABLE FEATURES OF BUILDING OR SITE (interior and/or exterior)
	<p>Three-bay facade, right entry, louvered door. Rectangular sidelights, paneled entry pilasters. Above, plain architrave and frieze, simple molded cap. Sash 2-over-2 on first floor, 6-over-6 in attic. Plain corner pilasters. Plain architrave and frieze. Molded cornice, partial return.</p> <p>Left elevation has rectangular bay window with matching pilasters. Right has Victorian bay window over panels with molded cornice on small jigsaw brackets with leaf cut-outs. To the rear, two attached sheds connect to a small barn.</p>
