**HISTORIC RESOURCES INVENTORY**  
**BUILDING AND STRUCTURES**  
 HIST-6 NEW 5/77

IDENTIFICATION	1. BUILDING NAME (Common) _____ (Historic) _____	
	2. TOWN CITY THOMPSON	VILLAGE THOMPSON
	3. STREET AND NUMBER (and/or location) 78 ROUTE 200 (342 THOMPSON HILL RD.) 105/40-21

6. ACCESSIBILITY TO PUBLIC: EXTERIOR VISIBLE FROM PUBLIC ROAD <input checked="" type="checkbox"/> Yes <input type="checkbox"/> No INTERIOR ACCESSIBLE <input type="checkbox"/> Yes <input checked="" type="checkbox"/> No IF YES, EXPLAIN _____	
DESCRIPTION	7. STYLE OF BUILDING Vernacular	
	DATE OF CONSTRUCTION c. 1800

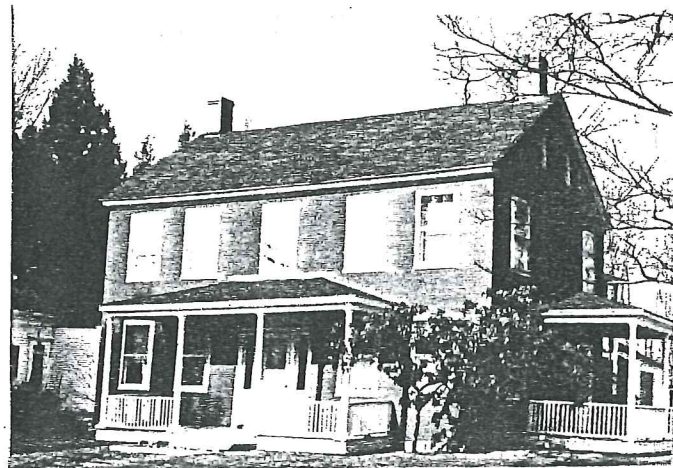
PHOTO	PHOTOGRAPHER Mark McDonough	DATE 1986
	VIEW NW	NEGATIVE ON FILE G25
COMPILED BY	NAME Mark McDonough	DATE 1986
	ORGANIZATION Town of Thompson, Connecticut	
	ADDRESS

11. NUMBER OF STORIES APPROXIMATE DIMENSIONS 2 1/2 35' x 25'		
12. CONDITION (Structural) (Exterior)		
<input type="checkbox"/> Excellent	<input type="checkbox"/> Good	
<input checked="" type="checkbox"/> Fair	<input type="checkbox"/> Deteriorated	
<input type="checkbox"/> Excellent	<input type="checkbox"/> Good	
<input checked="" type="checkbox"/> Fair	<input type="checkbox"/> Deteriorated

Five-bay facade, central entry, 6-over-1 sash. Brick walls are common bond with occasional header courses. Door has one large light over panels. Single-pane rectangular sidelights over panels. Semi-elliptical clapboard sunburst above.

Three-bay one-story porch on slender Tuscan-columns, recent two-by-four railing. Windows paired slightly and offset towards corners of house. Second-floor windows located relatively high under eaves. Molded cornice shows partial return. Twin brick chimneys.

Right elevation has side entry with similar porch. To rear, old cross-gabled frame wing.
