HISTORIC RESOURCES INVENTORY
BUILDING AND STRUCTURES
 HIST-6 NEW 5/77

| IDENTIFICATION | 1. BUILDING NAME (Common) (Historic) | | WILLIAM WALKER HOUSE | | |
| | 124 ROUTE 193 (1333 THOMPSON RD.) | | | | |

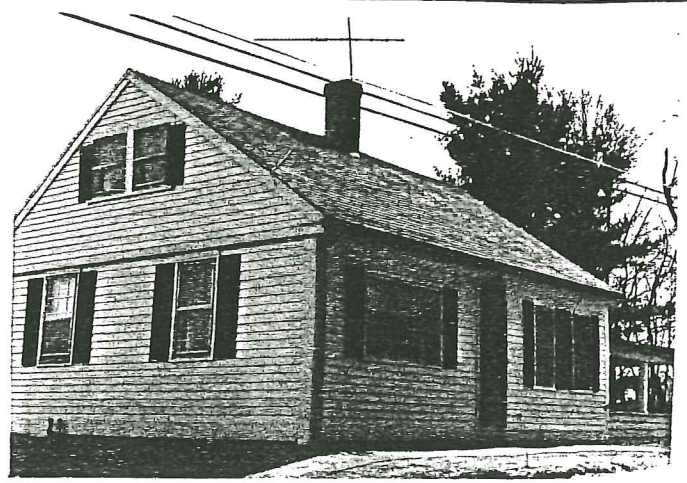
| | VIEW S | NEGATIVE ON FILE J27 |

Five-bay facade with central entry. First and second bays now occupied by modern picture window. Heavy paneled door is old if not original. Narrow plain entry surround, rectangular glazed transom. Sash generally 2-over-2, small central brick chimney.

Plain corner posts, bed molding, plain cornice. Slight overhang at gabled ends. Parallel one-and-one-half-story right wing appears to be mid 19th century addition. Wing was full width one story porch with square tapered posts, sided rail. One small 2-over-2 frieze band window, steep gable.
