HISTORIC RESOURCES INVENTORY
BUILDING AND STRUCTURES

2. TOWN CITY THOMPSON VILLAGE THOMPSON COUNTY WINDHAM

3. STREET AND NUMBER (and/or location) 428 ROUTE 193 (1161 THOMPSON RD.) 116/24-3

7. STYLE OF BUILDING Vernacular DATE OF CONSTRUCTION c. 1780

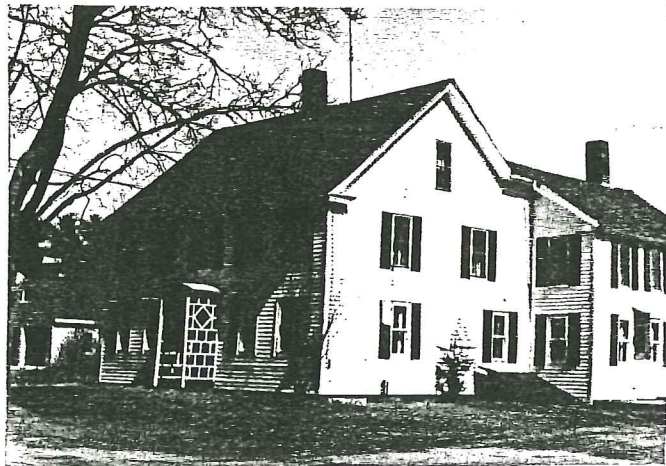
PHOTO	PHOTOGRAPHER Mark McDonough		DATE 1986
	VIEW NE	NEGATIVE ON FILE J29	
COMPILED BY	NAME Mark McDonough		DATE 1986
	ORGANIZATION Town of Thompson, Connecticut		
	ADDRESS

On original site Moved Yes No Extensive: recent siding, sash

Five-bay facade, central entry. Window bays paired and offset towards corners of house. Recent entry hood supported by lattice. Old 6-over-6 sash on second floor, 1-over-1 on first. Second floor windows high under eaves. Molded cornice shows partial return. Central brick chimney. Large cross-gabled rear wing.

Architecturally, it is significant as a good example of late 18th century vernacular architecture. The symmetrical five-bay facade, central entry and chimney, and the ridge-parallel-to-street form are all typical of 18th century practice.
