HISTORIC RESOURCES INVENTORY
BUILDING AND STRUCTURES
 HIST-6 NEW 5/77

IDENTIFICATION	1. BUILDING NAME (Common) (Historic)		DAVID PLUMMER HOUSE	
	2. TOWN CITY		VILLAGE	COUNTY
	THOMPSON		THOMPSON	WINDHAM
	3. STREET AND NUMBER (and/or location)		118/29-15	
	539 ROUTE 193 (1096 THOMPSON RD.)

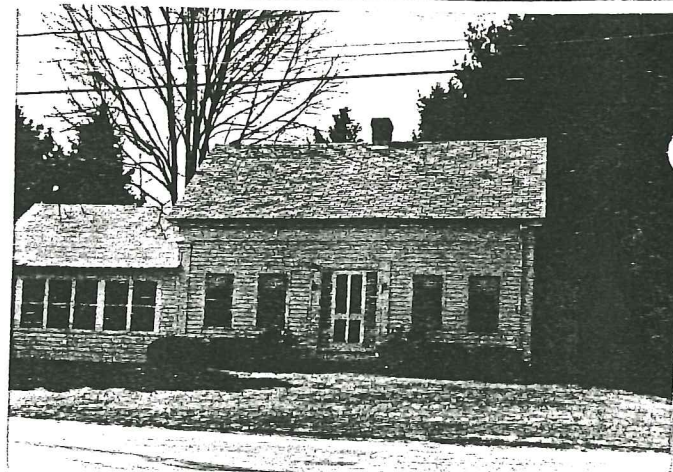
PHOTO	PHOTOGRAPHER Mark McDonough	DATE 1986
	VIEW W	NEGATIVE ON FILE J31
COMPILED BY	NAME Mark McDonough	DATE 1986
	ORGANIZATION Town of Thompson, Connecticut	
	ADDRESS

11. NUMBER OF STORIES		APPROXIMATE DIMENSIONS		
1 1/2		32' x 23'		
12. CONDITION (Structural) (Exterior)				
<input type="checkbox"/> Excellent <input checked="" type="checkbox"/> Good <input type="checkbox"/> Fair <input type="checkbox"/> Deteriorated <input type="checkbox"/> Excellent <input checked="" type="checkbox"/> Good <input type="checkbox"/> Fair <input type="checkbox"/> Deteriorated

13. INTEGRITY (Location)		WHEN?	(Alterations)	
<input checked="" type="checkbox"/> On original site <input type="checkbox"/> Moved			<input checked="" type="checkbox"/> Yes <input type="checkbox"/> No	
			IF YES, EXPLAIN	
			Later storm sash, porch

Five-bay facade. Central entry has original heavy paneled door, rectangular sidelights over panels. Paneled entry pilasters and lintel with plain corner blocks. Sash generally old 6-over-6. Wide plain frieze, paneled corner pilasters with molded capitals. Molded cornice shows partial return, central brick chimney.

Right elevation has old small blind bay. Left has lower old parallel ell, altered entry originally similar to front in endwall.
