HISTORIC RESOURCES INVENTORY
BUILDING AND STRUCTURES
 HIST-6 NEW 5/77

1. BUILDING NAME (Common)		(Historic)	
		BAPTIST PARSONAGE	
2. TOWN CITY		VILLAGE	COUNTY
THOMPSON		THOMPSON	WINDHAM
3. STREET AND NUMBER (and/or location)			
4 BRANDY HILL ROAD		(59 BRANDY HILL RD.)	122/18-7

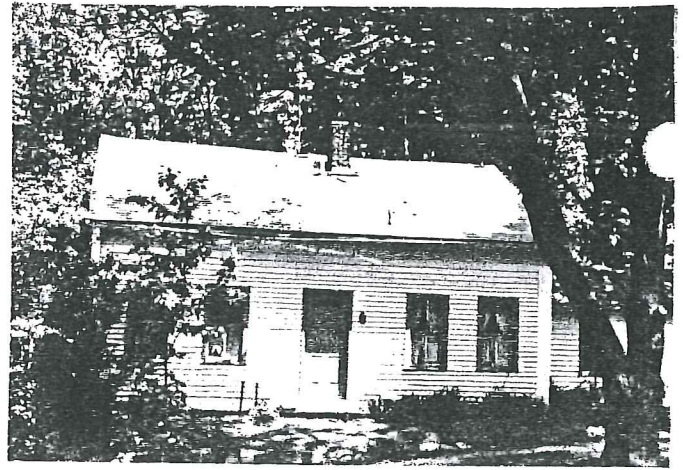
11. NUMBER OF STORIES		APPROXIMATE DIMENSIONS	
1 1/2		30' x 25'	
12. CONDITION (Structural)		(Exterior)	
<input type="checkbox"/> Excellent	<input checked="" type="checkbox"/> Good	<input type="checkbox"/> Fair	<input type="checkbox"/> Deteriorated
		<input type="checkbox"/> Excellent	<input checked="" type="checkbox"/> Good
		<input type="checkbox"/> Fair	<input type="checkbox"/> Deteriorated

PHOTO	PHOTOGRAPHER Mark McDonough		DATE 1986
	VIEW N	NEGATIVE ON FILE M12	
COMPILED BY	NAME Mark McDonough		DATE 1986
	ORGANIZATION Town of Thompson, Connecticut		
	ADDRESS

Five-bay facade; central entry has modern door with bell panes. Sash 2-over-2. Wide plain corner boards and frieze. Lower parallel right ell with additional entry.
