**Thompson  
Historical  
Society**

## **Historic Record of Property and Places in Thompson, CT**

**Property Address:** 196 Hill Road

**Historical Property Name (if applicable):** Alpheus Russell

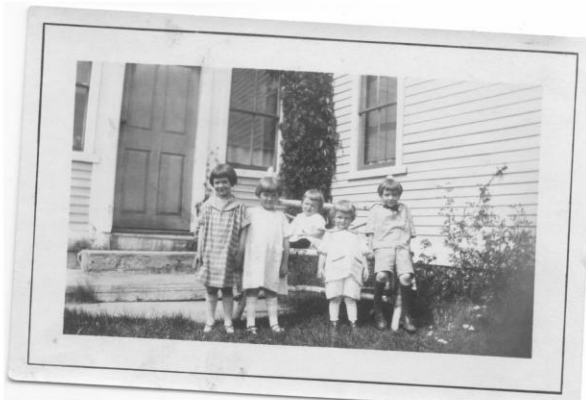
P0002546 (revised)

Hill Road 1924  
 From left  
 Unidentified  
 Rachel Rawson Bennett  
 David Rawson  
 Nathan Rawson  
 Allan Logee  
 First 3  
 children of Edward &  
 Bertha Rawson. ~~Richard~~  
 Richard was born later.

From William DeGregorio: "You see that one window in No. 2546, in the photo of the five children standing at the corner of the new addition and the old house in 1924. That is definitely us, as is the photo of the horse and cart in front of the retaining wall. That image confirms something I have long wondered about, which is if there ever was a porch. The enormous barn behind it is fascinating, as there is absolutely no trace of it today. However, the house and property have clearly been through many apparently quite drastic changes. I believe one of the more recent owners essentially took the house down to the studs, and rebuilt many interior features, though they retained as much of the antique material as possible. It must have been an enormous job, and probably cost more than we paid for the house. I ran into one of the other previous owners, Jeff Woods (I believe a Historical Society member), and he told me he was the one that put up the current outbuildings, which include two sheds and a gazebo, and rebuilt some of the large wall in back after excavating debris that had filled the interior. He also mentioned doing a lot of regrading work, so the current topography of the land is probably quite different than during the early 20th century. The large barn on the east side of the house must have extended well down into our neighbor's current property."

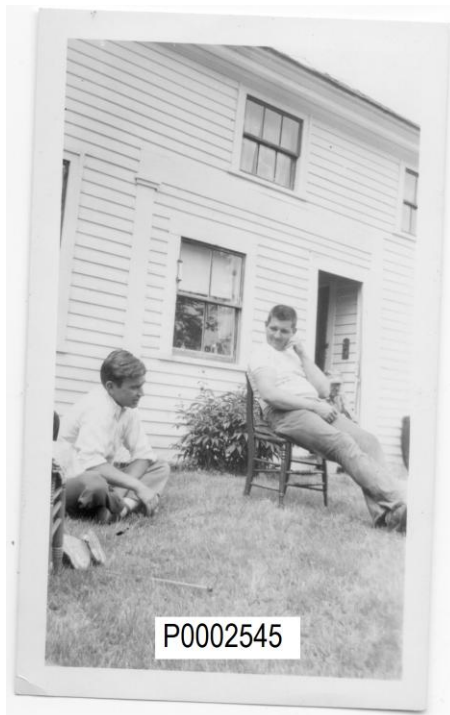
Mark Snay: "Photo #P0002545 only had a listed description as being from the David Rawson family."

William DeGregorio: "The image of the two men sitting outside is more intriguing though, as it could very well be the back/North facade of the house during a period when the lawn came straight up to the door jamb. Currently the basement masonry is quite visible and the door rises about two feet from the ground. The windows are seemingly in the right places."
